# Access Compliance Report

## Public Rights-of-Way

### (Curb Ramps)

Intersection ID: 11686	Main Street: BRISTOL_DR	Cross Street: CARLYLE_DR	Location: SE
ADA ID: 533364C32323	Ramp Type: Perp	Initial Pass/Fail: Fail	Overall Compliance: No
		Severity Score: 10

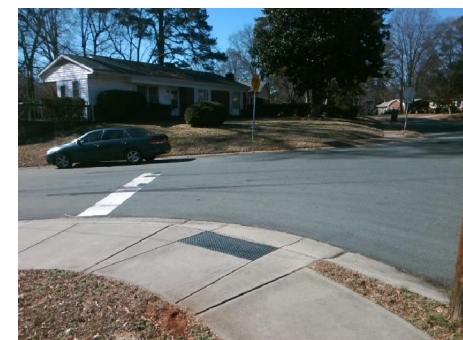
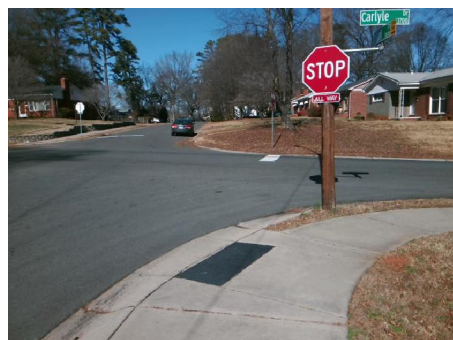
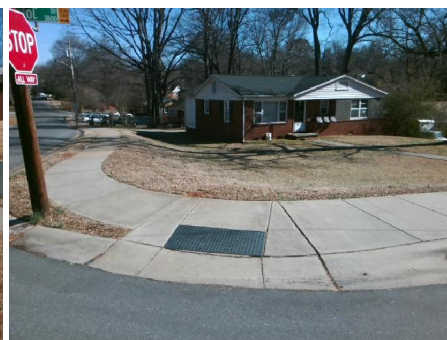
**Not Found, R304.5.1, R304.5.3**

Compliance	Description	Data	Compliance	Description	Data
N/A	Ramp Length (in)	73.0	Yes	Ramp Slope (%)	6.8
No	Ramp Width (in)	47.0	No	Ramp XSlope (%)	3.2
N/A	Flare Type LT	N/A	N/A	Flare Type RT	N/A
N/A	Flare Slope LT (%)	N/A	N/A	Flare Slope RT (%)	N/A
N/A	Flare Traversable LT?	N/A	N/A	Flare Traversable RT?	N/A
N/A	Landing Length (in)	N/A	N/A	DWS Provided?	N/A
N/A	Landing Width (in)	N/A	N/A	DWS Contrast?	N/A
N/A	Landing Slope (%)	N/A	N/A	DWS Length (in)	N/A
N/A	Landing X Slope (%)	N/A	N/A	DWS Full Width?	N/A
N/A	Landing Curb? (Y/N)	N/A	N/A	DWS Offset (in)	N/A
N/A	Shared Landing?	N/A			
N/A	Gutter Ponding?	N/A	N/A	Gutter Slope (%)	N/A
N/A	Gutter Lip Ht (in)	N/A	N/A	Gutter X Slope (%)	N/A
N/A	Painted X Walk1?	No	N/A	Painted X Walk2?	N/A
	X Walk 1 Direction	To NW		X Walk 2 Direction	N/A
N/A	X Walk 1 Width (in)	N/A	N/A	X Walk 2 Width (in)	N/A
	X Walk 1 Slope (%)	3.9		X Walk 2 Slope (%)	N/A
	X Walk 1 X Slope (%)	4.3		X Walk 2 X Slope (%)	N/A

N/A	Ramp inside XWalk1?	N/A	N/A	Ramp inside XWalk2?	N/A
	Road Slope (%)	N/A	N/A	Clear Space?	N/A
	Road X Slope (%)	N/A	N/A	Clear Space to XWalk (in)	N/A
N/A	Any Obstructions?	N/A	N/A	Storm Grate/Utility Hazard?	N/A
	Obstruction Type			Storm Grate/Utility Type	
		N/A			N/A
			Yes	Surface Condition? (G/P)	Good

**Remove & Replace Entire Ramp.**

Total Cost: \$ 1850.00
