Access Compliance Report Public Rights-of-Way (Curb Ramps)

Intersection ID: 53885 Main Street: PAW_VILLAGE_RD Cross Street: PATHWAY_CT Location: S

ADA ID: 53426B0AF4DD Ramp Type: BlendTrans1 Initial Pass/Fail: Fail Overall Compliance: No Severity Score: 12.5

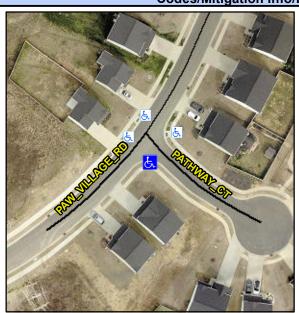
Not Found, R304.5.3

Compliance Description Data Compliance Description Data Yes N/A Ramp Length (in) 50.0 BlendTrans Slope (%) 1.6 48.0 No Yes Ramp Width (in) BlendTrans XSlope (%) 6.9 N/A N/A Flare Type LT N/A Flare Type RT N/A N/A Flare Slope LT (%) N/A N/A Flare Slope RT (%) N/A N/A Flare Traversable LT? N/A N/A Flare Traversable RT? N/A N/A Landing Length (in) N/A N/A **DWS Provided?** N/A N/A Landing Width (in) N/A N/A **DWS Contrast?** N/A N/A N/A N/A Landing Slope (%) DWS Length (in) N/A N/A Landing X Slope (%) N/A N/A DWS Full Width? N/A N/A Landing Curb? (Y/N) N/A N/A DWS Offset (in) N/A N/A N/A Shared Landing? N/A **Gutter Ponding?** N/A N/A Gutter Slope (%) N/A N/A Gutter Lip Ht (in) N/A N/A Gutter X Slope (%) N/A N/A Painted X Walk1? No N/A Painted X Walk2? No X Walk 1 Direction To NE X Walk 2 Direction To NW N/A X Walk 1 Width (in) X Walk 2 Width (in) N/A X Walk 1 Slope (%) 8.0 X Walk 2 Slope (%) 1.4 X Walk 1 X Slope (%) 1.5 X Walk 2 X Slope (%) 9.7 N/A N/A Ramp inside XWalk2? N/A N/A Ramp inside XWalk1? Road Slope (%) 10.0 Clear Space? N/A Road X Slope (%) 5.4 N/A Clear Space to XWalk (in) N/A N/A N/A N/A Any Obstructions? Storm Grate/Utility Hazard? N/A **Obstruction Type** Storm Grate/Utility Type N/A N/A Yes Surface Condition? (G/P) Good No Curb Slope (%) 10.4

PATHWAY CT StopSign PAW VILLIAGE RD None Possible Solutions:

Remove & Replace Curb Ramp With Two New Directional Ramps or Equivalent.
