Access Compliance Report

Public Rights-of-Way

(Curb Ramps)

Intersection ID: 25495	Main Street: CARMEL_RD	Cross Street: WATERFORD_SQUARE_DR	Location: SW
ADA ID: 53572FC89E68	Ramp Type: PerpDiag	Initial Pass/Fail: Fail	Overall Compliance: No
Severity Score: 8.75			
Codes/Mitigation Info/Possible Solution		Field Measurements/Component Compliance

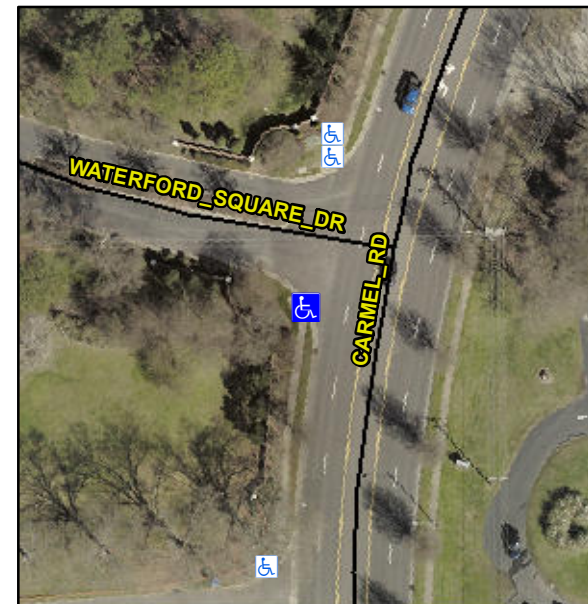
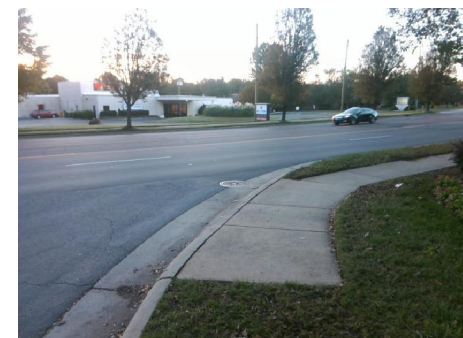
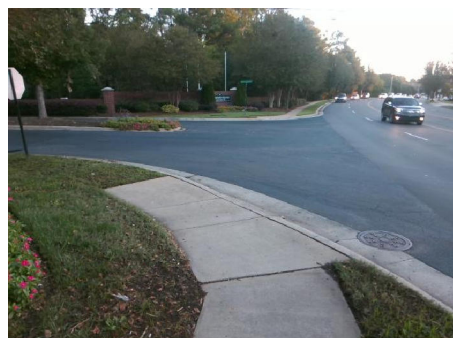
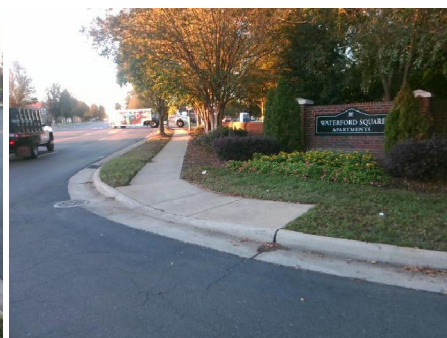
Not Found, R304.5.1

Compliance	Description	Data	Compliance	Description	Data
N/A	Ramp Length (in)	60.0	Yes	Ramp Slope (%)	5.4
No	Ramp Width (in)	42.0	Yes	Ramp XSlope (%)	1.3
N/A	Flare Type LT	N/A	N/A	Flare Type RT	N/A
N/A	Flare Slope LT (%)	N/A	N/A	Flare Slope RT (%)	N/A
N/A	Flare Traversable LT?	N/A	N/A	Flare Traversable RT?	N/A
N/A	Landing Length (in)	N/A	N/A	DWS Provided?	N/A
N/A	Landing Width (in)	N/A	N/A	DWS Contrast?	N/A
N/A	Landing Slope (%)	N/A	N/A	DWS Length (in)	N/A
N/A	Landing X Slope (%)	N/A	N/A	DWS Full Width?	N/A
N/A	Landing Curb? (Y/N)	N/A	N/A	DWS Offset (in)	N/A
N/A	Shared Landing?	N/A			
N/A	Gutter Ponding?	N/A	N/A	Gutter Slope (%)	N/A
N/A	Gutter Lip Ht (in)	N/A	N/A	Gutter X Slope (%)	N/A
N/A	Painted X Walk1?	No	N/A	Painted X Walk2?	No
	X Walk 1 Direction	To SE		X Walk 2 Direction	To NE
N/A	X Walk 1 Width (in)	N/A	N/A	X Walk 2 Width (in)	N/A
	X Walk 1 Slope (%)	1.3		X Walk 2 Slope (%)	1.8
	X Walk 1 X Slope (%)	1.5		X Walk 2 X Slope (%)	2.0

N/A	Ramp inside XWalk1?	N/A	N/A	Ramp inside XWalk2?	N/A
	Road Slope (%)	0.5	N/A	Clear Space?	N/A
	Road X Slope (%)	1.6	N/A	Clear Space to XWalk (in)	N/A
N/A	Any Obstructions?	N/A	N/A	Storm Grate/Utility Hazard?	N/A
	Obstruction Type			Storm Grate/Utility Type	
		N/A			N/A
			Yes	Surface Condition? (G/P)	Good

Possible Solutions:

Remove & Replace Curb Ramp With Two New Directional Ramps or Equivalent.
