# Access Compliance Report

## Public Rights-of-Way

### (Curb Ramps)

Intersection ID: 16088		Main Street: OXFORD_PL		Cross Street: QUEENS_RD		Location: NE							
ADA ID: 5360C2F0196D		Ramp Type: Directional1		Initial Pass/Fail: Fail		Overall Compliance: No		Severity Score: 1.25					
Codes/Mitigation Info/Possible Solution				Field Measurements/Component Compliance

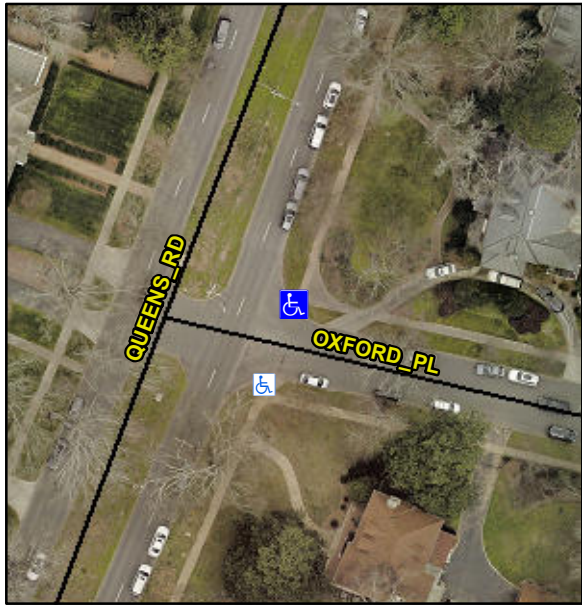
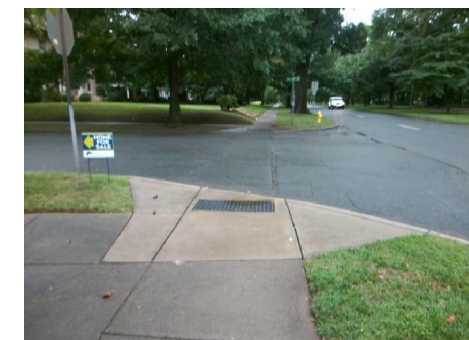
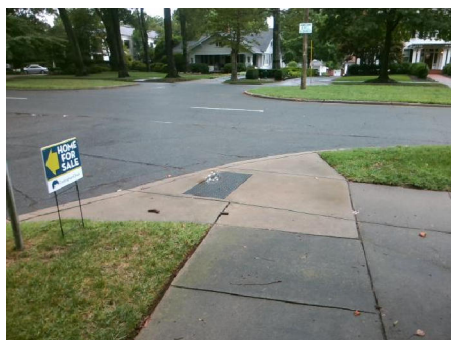
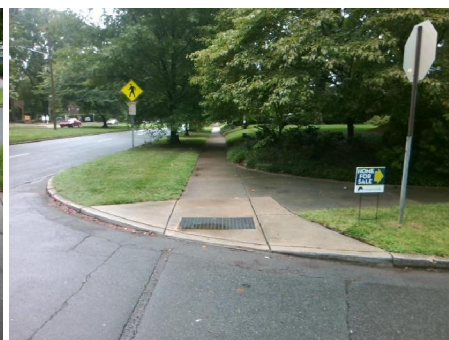
Possible Solutions:		Compliance		Description		Data			
				Remove & Replace Entire Ramp.		N/A	Ramp Length (in)	26.0		N/A	Grade Break?	N/A	
Surveyor Notes:				N/A		Yes	Ramp Width (in)	58.0		N/A	Grade Break Slope (%)	0.0	
						Yes	Ramp Slope (%)	2.2		N/A	Grade Break XSlope (%)	0.0	
PROW/ADA:				R304.5.3		No	Ramp XSlope (%)	2.6					
						N/A	Flare Type LT	N/A		N/A	Flare Type RT	N/A	
						N/A	Flare Slope LT (%)	N/A		N/A	Flare Slope RT (%)	0.0	
						N/A	Flare Traversable LT?	N/A		N/A	Flare Traversable RT?	N/A	
						N/A	Landing Length (in)	0.0		N/A	DWS Provided?	N/A	
						N/A	Landing Width (in)	0.0		N/A	DWS Contrast?	N/A

N/A	Landing Slope (%)	0.0		N/A	DWS Length (in)	N/A	
						N/A	Landing X Slope (%)	0.0		N/A	DWS Full Width?	N/A	
						N/A	Landing Curb? (Y/N)	N/A		N/A	DWS Offset LT (in)	N/A	
						N/A	Shared Landing?	N/A		N/A	DWS Offset RT (in)	N/A	
						N/A	Gutter Ponding?	0.0		N/A	Gutter Slope (%)	N/A	
						N/A	Gutter Lip Ht (in)	0.0		N/A	Gutter X Slope (%)	N/A	
						N/A	Painted X Walk1?	No			Road Slope (%)	3.8	
							X Walk 1 Direction	To S			Road X Slope (%)	1.6	
							X Walk 1 Width (in)	N/A			Clear Space?	N/A	
							X Walk 1 Slope (%)	3.8		N/A	Clear Space to XWalk (in)	N/A	
							X Walk 1 X Slope (%)	1.6		N/A	Storm Grate/Utility Hazard?	N/A	
						N/A	Ramp inside XWalk1?	N/A			Storm Grate/Utility Type		
						N/A	Any Obstructions?	N/A				N/A	
							Obstruction Type			Yes	Surface Condition? (G/P)	Good	
										N/A	Curb Slope (%)	9.2	
Total Cost:				\$	1600.00
