# Access Compliance Report

## Public Rights-of-Way

Intersection ID: 13149	Main Street: CENTRAL_AV	Cross Street: THE_PLAZA	Location: NW
ADA ID: 5371403AEDCB	Ramp Type: Perp	Initial Pass/Fail: Fail	Overall Compliance: No
			Severity Score: 48.75

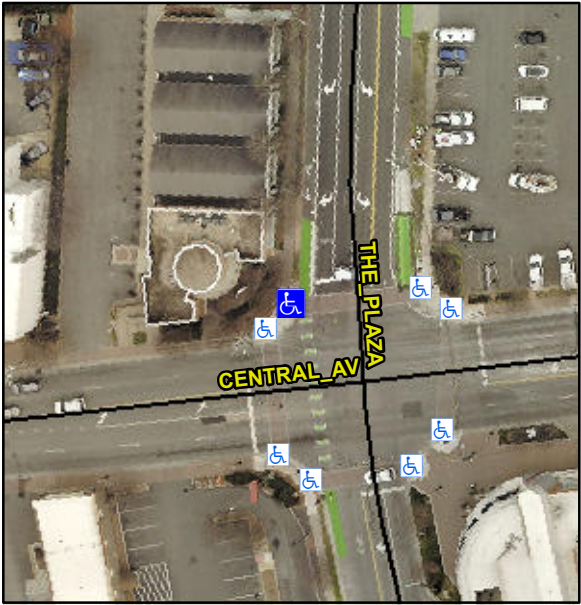
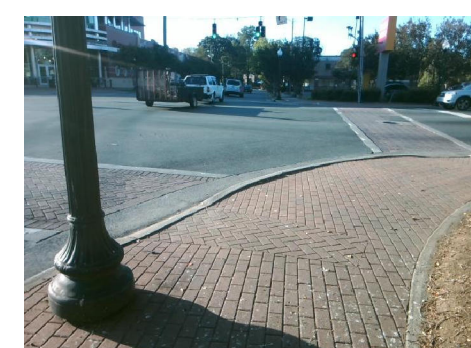
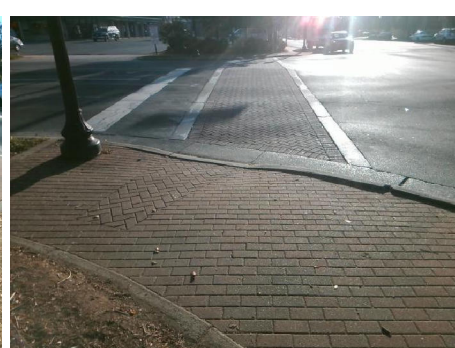
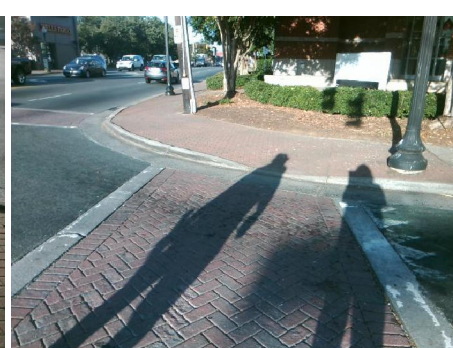
Possible Solutions:		<b>Compliance</b>	<b>Description</b>	<b>Data</b>
	<b>Remove &amp; Replace Entire Ramp.</b>		<b>No</b>	Ramp Length (in)	81.0
			<b>No</b>	Ramp Width (in)	30.0
			<b>N/A</b>	Flare Type LT	N/A
			<b>N/A</b>	Flare Slope LT (%)	N/A
			<b>N/A</b>	Flare Traversable LT?	N/A
			<b>N/A</b>	Landing Length (in)	N/A
			<b>N/A</b>	Landing Width (in)	N/A
			<b>N/A</b>	Landing Slope (%)	N/A
			<b>N/A</b>	Landing X Slope (%)	N/A
<p>Surveyor Notes:</p> <p><b>N/A</b></p> <p>PROW/ADA:</p> <p><b>Not Found, R304.5.1, R304.2.2, R304.5.3</b></p>			<b>N/A</b>	Flare Type RT	N/A
			<b>N/A</b>	Flare Slope RT (%)	N/A
			<b>N/A</b>	Flare Traversable RT?	N/A
			<b>N/A</b>	DWS Provided?	N/A
			<b>N/A</b>	DWS Contrast?	N/A
			<b>N/A</b>	DWS Length (in)	N/A
			<b>N/A</b>	DWS Full Width?	N/A
			<b>N/A</b>	DWS Offset (in)	N/A
			<b>N/A</b>	Shared Landing?	N/A

<b>N/A</b>	Gutter Ponding?	N/A
			<b>N/A</b>	Gutter Lip Ht (in)	N/A
			<b>N/A</b>	Painted X Walk1?	Yes
				X Walk 1 Direction	To E
			<b>N/A</b>	X Walk 1 Width (in)	96.0
				X Walk 1 Slope (%)	5.2
				X Walk 1 X Slope (%)	0.3
			<b>N/A</b>	Ramp inside XWalk1?	Yes
				Road Slope (%)	N/A
				Road X Slope (%)	N/A
			<b>N/A</b>	Any Obstructions?	N/A
Total Cost:		\$ 1850.00		Obstruction Type	
			<b>N/A</b>		N/A
			<b>Yes</b>	Surface Condition? (G/P)	Good
