# Access Compliance Report

## Public Rights-of-Way

### (Curb Ramps)

Intersection ID: 23386	Main Street: ALEXANDER_RD	Cross Street: BENNING_WOOD_DR	Location: NE
ADA ID: 537525F20FFB	Ramp Type: Directional1	Initial Pass/Fail: Fail	Overall Compliance: No
Severity Score: 1.25			
Codes/Mitigation Info/Possible Solution		Field Measurements/Component Compliance

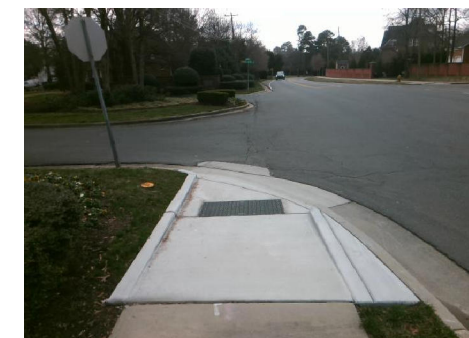
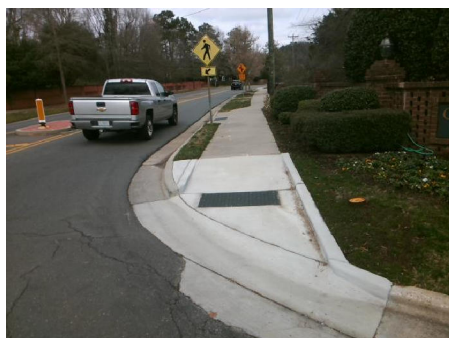
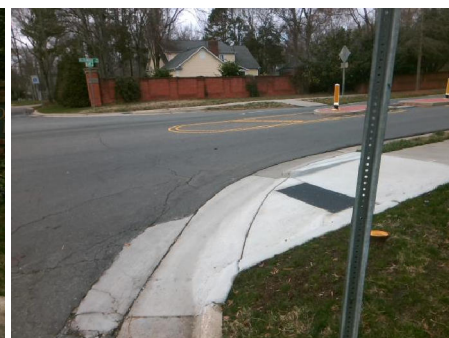
Compliance	Description	Data	Compliance	Description	Data
N/A	Ramp Length (in)	85.0	N/A	Grade Break?	N/A
Yes	Ramp Width (in)	70.5	N/A	Grade Break Slope (%)	0.0
Yes	Ramp Slope (%)	7.7	N/A	Grade Break XSlope (%)	0.0
No	Ramp XSlope (%)	2.1			
N/A	Flare Type LT	N/A	N/A	Flare Type RT	N/A
N/A	Flare Slope LT (%)	N/A	N/A	Flare Slope RT (%)	0.0
N/A	Flare Traversable LT?	N/A	N/A	Flare Traversable RT?	N/A
N/A	Landing Length (in)	0.0	N/A	DWS Provided?	N/A
N/A	Landing Width (in)	0.0	N/A	DWS Contrast?	N/A
N/A	Landing Slope (%)	0.0	N/A	DWS Length (in)	N/A
N/A	Landing X Slope (%)	0.0	N/A	DWS Full Width?	N/A
N/A	Landing Curb? (Y/N)	N/A	N/A	DWS Offset LT (in)	N/A
N/A	Shared Landing?	N/A	N/A	DWS Offset RT (in)	N/A
N/A	Gutter Ponding?	0.0	N/A	Gutter Slope (%)	N/A
N/A	Gutter Lip Ht (in)	0.0	N/A	Gutter X Slope (%)	N/A
N/A	Painted X Walk1?	No		Road Slope (%)	0.1
	X Walk 1 Direction	To SW		Road X Slope (%)	6.5
	X Walk 1 Width (in)	N/A		Clear Space?	N/A

X Walk 1 Slope (%)	0.1	N/A	Clear Space to XWalk (in)	N/A
	X Walk 1 X Slope (%)	6.5	N/A	Storm Grate/Utility Hazard?	N/A
N/A	Ramp inside XWalk1?	N/A		Storm Grate/Utility Type	
N/A	Any Obstructions?	N/A			N/A
	Obstruction Type		Yes	Surface Condition? (G/P)	Good
			N/A	Curb Slope (%)	7.7

**Remove & Replace Entire Ramp.**
