Access Compliance Report

Public Rights-of-Way

(Curb Ramps)

Intersection ID: 15377	Main Street: ELMHURST_RD	Cross Street: HAVERFORD_PL	Location: E
ADA ID: 53793914A370	Ramp Type: PerpDiag	Initial Pass/Fail: Fail	Overall Compliance: No
			Severity Score: 28.75

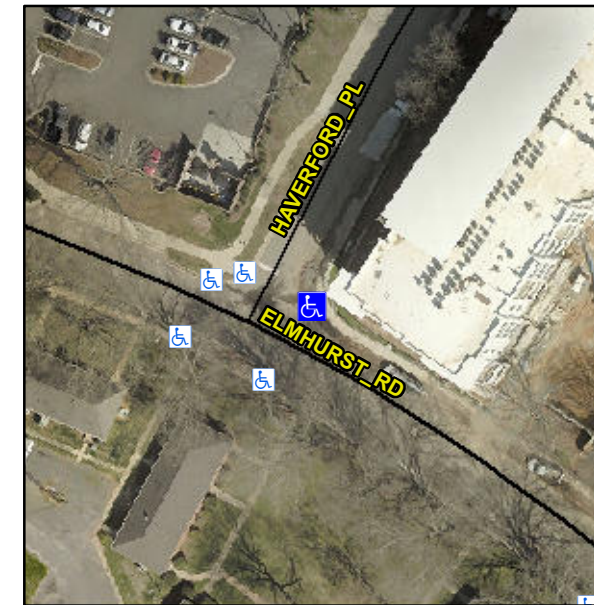
Not Found, R304.2.2, R304.5.3, R302.7

Compliance	Description	Data	Compliance	Description	Data
N/A	Ramp Length (in)	61.0	No	Ramp Slope (%)	9.2
Yes	Ramp Width (in)	60.0	No	Ramp XSlope (%)	2.5
N/A	Flare Type LT	N/A	N/A	Flare Type RT	N/A
N/A	Flare Slope LT (%)	N/A	N/A	Flare Slope RT (%)	N/A
N/A	Flare Traversable LT?	N/A	N/A	Flare Traversable RT?	N/A
N/A	Landing Length (in)	N/A	N/A	DWS Provided?	N/A
N/A	Landing Width (in)	N/A	N/A	DWS Contrast?	N/A
N/A	Landing Slope (%)	N/A	N/A	DWS Length (in)	N/A
N/A	Landing X Slope (%)	N/A	N/A	DWS Full Width?	N/A
N/A	Landing Curb? (Y/N)	N/A	N/A	DWS Offset (in)	N/A
N/A	Shared Landing?	N/A			
N/A	Gutter Ponding?	N/A	N/A	Gutter Slope (%)	N/A
N/A	Gutter Lip Ht (in)	N/A	N/A	Gutter X Slope (%)	N/A
N/A	Painted X Walk1?	No	N/A	Painted X Walk2?	No
	X Walk 1 Direction	To NW		X Walk 2 Direction	To SW
N/A	X Walk 1 Width (in)	N/A	N/A	X Walk 2 Width (in)	N/A
	X Walk 1 Slope (%)	2.8		X Walk 2 Slope (%)	0.1
	X Walk 1 X Slope (%)	1.9		X Walk 2 X Slope (%)	1.2

N/A	Ramp inside XWalk1?	N/A	N/A	Ramp inside XWalk2?	N/A
	Road Slope (%)	0.3	N/A	Clear Space?	N/A
	Road X Slope (%)	0.8	N/A	Clear Space to XWalk (in)	N/A
N/A	Any Obstructions?	N/A	N/A	Storm Grate/Utility Hazard?	N/A
	Obstruction Type			Storm Grate/Utility Type	
		N/A			N/A
		No		Surface Condition? (G/P)	Poor

Remove & Replace Curb Ramp With Two New Directional Ramps or Equivalent.
