Access Compliance Report

Public Rights-of-Way

(Curb Ramps)

Intersection ID: 16415	Main Street: BEVERLY_DR	Cross Street: SHERWOOD_AV	Location:	N
ADA ID: 53831E99771C	Ramp Type: Combination2Diag	Initial Pass/Fail: Fail	Overall Compliance: No	Severity Score: 0

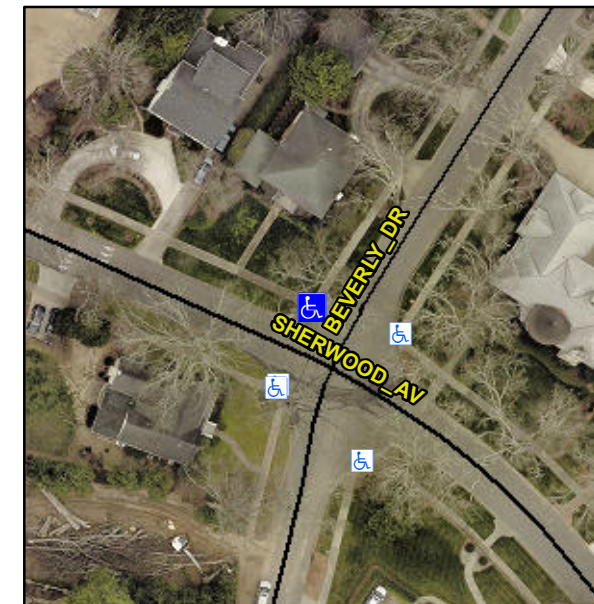
ASP LIP 1.0

Not Found, R304.5.1, R304.2.2, R304.3.2

Compliance	Description	Data	Compliance	Description	Data
N/A	Ramp Length LT (in)	33.0	N/A	Ramp Length RT (in)	N/A
No	Ramp Width LT (in)	35.0	N/A	Ramp Width RT (in)	N/A
No	Ramp Slope LT (%)	8.9	N/A	Ramp Slope RT (%)	N/A
Yes	Ramp XSlope LT (%)	0.7	N/A	Ramp XSlope RT (%)	N/A
N/A	Ramp Length (in)	28.5	No	Ramp Slope (%)	12.7
Yes	Ramp Width (in)	60.0	Yes	Ramp XSlope (%)	1.0
N/A	Flare Type LT	N/A	N/A	Flare Type RT	N/A
N/A	Flare Slope LT (%)	N/A	N/A	Flare Slope RT (%)	N/A
N/A	Flare Traversable LT?	N/A	N/A	Flare Traversable RT?	N/A
N/A	Landing Length (in)	N/A	N/A	DWS Provided?	N/A
N/A	Landing Width (in)	N/A	N/A	DWS Contrast?	N/A
N/A	Landing Slope (%)	N/A	N/A	DWS Length (in)	N/A
N/A	Landing X Slope (%)	N/A	N/A	DWS Full Width?	N/A
N/A	Landing Curb? (Y/N)	N/A	N/A	DWS Offset (in)	N/A
N/A	Shared Landing?	N/A			
N/A	Gutter Ponding?	N/A	N/A	Gutter Slope (%)	N/A
N/A	Gutter Lip Ht (in)	N/A	N/A	Gutter X Slope (%)	N/A
N/A	Painted X Walk1?	No	N/A	Painted X Walk2?	No

X Walk 1 Direction	To SW		X Walk 2 Direction	To E
	X Walk 1 Width (in)	N/A		X Walk 2 Width (in)	N/A
	X Walk 1 Slope (%)	5.0		X Walk 2 Slope (%)	0.3
	X Walk 1 X Slope (%)	0.1		X Walk 2 X Slope (%)	4.2
N/A	Ramp inside XWalk1?	N/A	N/A	Ramp inside XWalk2?	N/A
	Road Slope (%)	3.6		Clear Space?	N/A
	Road X Slope (%)	2.9	N/A	Clear Space to XWalk (in)	N/A
			N/A	Any Obstruction?	N/A
				Obstruction Type	N/A
			N/A	Storm Grate/Utility Hazard?	N/A
				Storm Grate/Utility Type	N/A
					N/A
Yes	Surface Condition? (G/P)	Good			
	Curb Slope (%)	10.1

Remove & Replace Curb Ramp With Two New Directional Ramps or Equivalent.
