Access Compliance Report

Public Rights-of-Way

(Curb Ramps)

| Intersection ID: N/A | Main Street: COLONEL FRANCIS J BEATTY DR | Cross Street: PARKGATE DR | Location: SW |

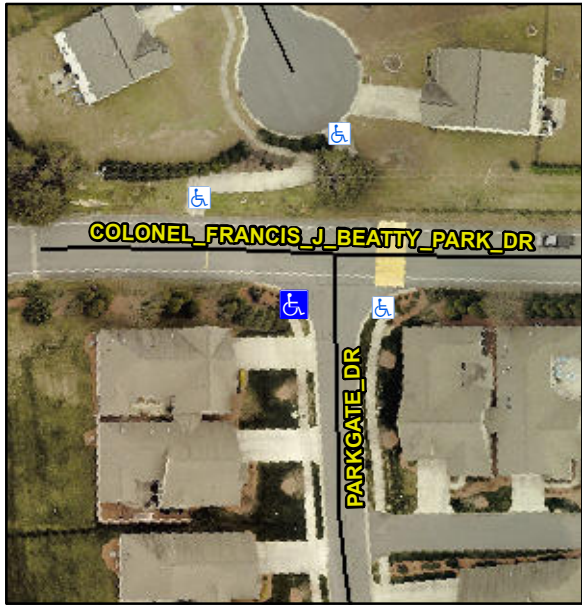
| ADA ID: 53840356AAF1 | Ramp Type: PerpDiag | Initial Pass/Fail: Fail | Overall Compliance: No |
| Severity Score: 21.25 | | | |

Not Found, R304.5.1, R304.2.2

| Compliance | Description | Data | Compliance | Description | Data |
|---|---|---|---|---|---|
| N/A | Ramp Length (in) | 47.0 | No | Ramp Slope (%) | 9.5 |
| No | Ramp Width (in) | 40.0 | Yes | Ramp XSlope (%) | 1.5 |

Remove & Replace Curb Ramp With Two New Directional Ramps or Equivalent.

3200.00
