Access Compliance Report

Public Rights-of-Way

(Curb Ramps)

Intersection ID: 20860	Main Street: CROWNPOINT_EXECUTIVE_DR	Cross Street: KREFELD_DR	Location: SE
ADA ID: 53A01045BCBF	Ramp Type: PerpDiag	Initial Pass/Fail: Fail	Overall Compliance: No
Severity Score: 25			
Codes/Mitigation Info/Possible Solution		Field Measurements/Component Compliance

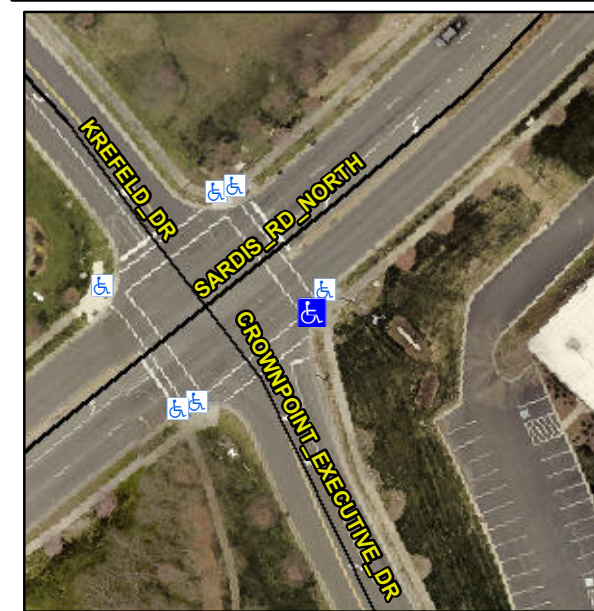
Not Found, R304.2.2, R304.5.3

Compliance	Description	Data	Compliance	Description	Data
N/A	Ramp Length (in)	66.0	No	Ramp Slope (%)	8.7
Yes	Ramp Width (in)	48.0	No	Ramp XSlope (%)	6.8
N/A	Flare Type LT	N/A	N/A	Flare Type RT	N/A
N/A	Flare Slope LT (%)	N/A	N/A	Flare Slope RT (%)	N/A
N/A	Flare Traversable LT?	N/A	N/A	Flare Traversable RT?	N/A
N/A	Landing Length (in)	N/A	N/A	DWS Provided?	N/A
N/A	Landing Width (in)	N/A	N/A	DWS Contrast?	N/A
N/A	Landing Slope (%)	N/A	N/A	DWS Length (in)	N/A
N/A	Landing X Slope (%)	N/A	N/A	DWS Full Width?	N/A
N/A	Landing Curb? (Y/N)	N/A	N/A	DWS Offset (in)	N/A
N/A	Shared Landing?	N/A			
N/A	Gutter Ponding?	N/A	N/A	Gutter Slope (%)	N/A
N/A	Gutter Lip Ht (in)	N/A	N/A	Gutter X Slope (%)	N/A
N/A	Painted X Walk1?	Yes	N/A	Painted X Walk2?	Yes
	X Walk 1 Direction	To NW		X Walk 2 Direction	To SW
N/A	X Walk 1 Width (in)	112.0	N/A	X Walk 2 Width (in)	111.0
	X Walk 1 Slope (%)	1.1		X Walk 2 Slope (%)	5.3
	X Walk 1 X Slope (%)	6.0		X Walk 2 X Slope (%)	0.4

N/A	Ramp inside XWalk1?	Yes	N/A	Ramp inside XWalk2?	Yes
	Road Slope (%)	7.9	N/A	Clear Space?	N/A
	Road X Slope (%)	0.2	N/A	Clear Space to XWalk (in)	N/A
N/A	Any Obstructions?	N/A	N/A	Storm Grate/Utility Hazard?	N/A
	Obstruction Type			Storm Grate/Utility Type	
		N/A			N/A
		Yes		Surface Condition? (G/P)	Good

Remove & Replace Curb Ramp With Two New Directional Ramps or Equivalent.
