Access Compliance Report

Public Rights-of-Way

(Curb Ramps)

Intersection ID: 31619	Main Street: DEREK CHRISTOPHER CT	Cross Street: MARIA CHRISTINA LN	Location: SE
ADA ID: 53A284B54D08	Ramp Type: Perp	Initial Pass/Fail: Fail	Overall Compliance: No
Codes/Mitigation Info/Possible Solution		Field Measurements/Component Compliance	
Severity Score: 8.75

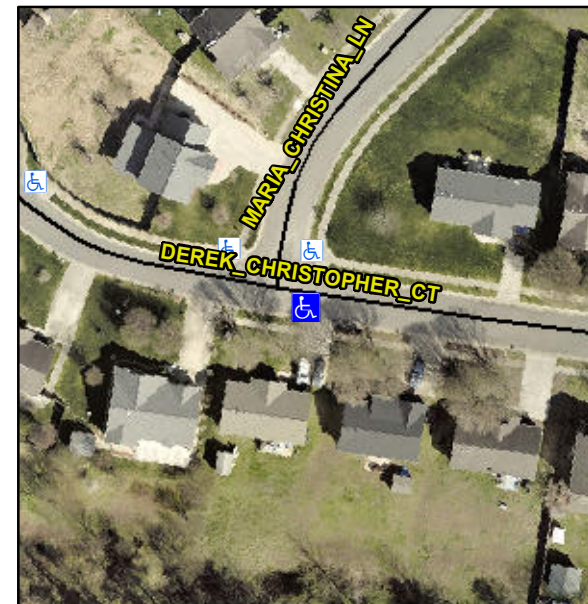
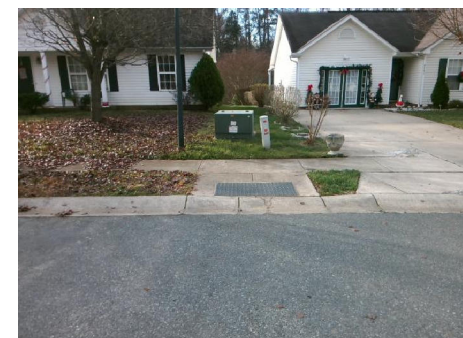
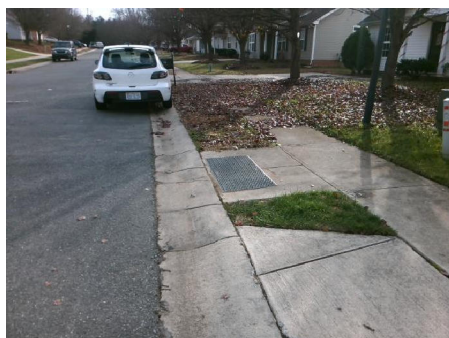
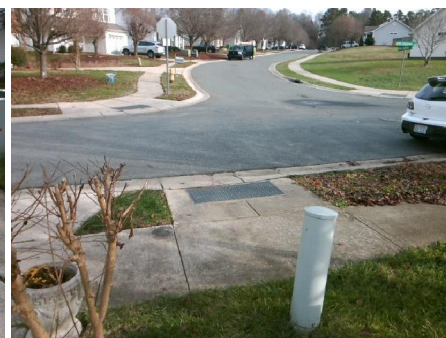
Not Found, R304.5.1

Compliance	Description	Data	Compliance	Description	Data
N/A	Ramp Length (in)	49.0	Yes	Ramp Slope (%)	5.0
No	Ramp Width (in)	45.5	Yes	Ramp XSlope (%)	1.1
N/A	Flare Type LT	N/A	N/A	Flare Type RT	N/A
N/A	Flare Slope LT (%)	N/A	N/A	Flare Slope RT (%)	N/A
N/A	Flare Traversable LT?	N/A	N/A	Flare Traversable RT?	N/A
N/A	Landing Length (in)	N/A	N/A	DWS Provided?	N/A
N/A	Landing Width (in)	N/A	N/A	DWS Contrast?	N/A
N/A	Landing Slope (%)	N/A	N/A	DWS Length (in)	N/A
N/A	Landing X Slope (%)	N/A	N/A	DWS Full Width?	N/A
N/A	Landing Curb? (Y/N)	N/A	N/A	DWS Offset (in)	N/A
N/A	Shared Landing?	N/A			
N/A	Gutter Ponding?	N/A	N/A	Gutter Slope (%)	N/A
N/A	Gutter Lip Ht (in)	0.5	N/A	Gutter X Slope (%)	N/A
N/A	Painted X Walk1?	No	N/A	Painted X Walk2?	N/A
	X Walk 1 Direction	To N		X Walk 2 Direction	N/A
N/A	X Walk 1 Width (in)	N/A	N/A	X Walk 2 Width (in)	N/A
	X Walk 1 Slope (%)	3.7		X Walk 2 Slope (%)	N/A
	X Walk 1 X Slope (%)	0.3		X Walk 2 X Slope (%)	N/A

N/A	Ramp inside XWalk1?	N/A	N/A	Ramp inside XWalk2?	N/A
	Road Slope (%)	N/A	N/A	Clear Space?	N/A
	Road X Slope (%)	N/A	N/A	Clear Space to XWalk (in)	N/A
N/A	Any Obstructions?	N/A	N/A	Storm Grate/Utility Hazard?	N/A
	Obstruction Type			Storm Grate/Utility Type	
		N/A			N/A
			Yes	Surface Condition? (G/P)	Good

Possible Solutions:

Remove & Replace Entire Ramp.

Total Cost: \$ 1850.00
