Access Compliance Report

Public Rights-of-Way

(Curb Ramps)

Intersection ID: 23966	Main Street: CAROLINA PAVILION DR N	Cross Street: SOUTH BV	Location: SW
ADA ID: 53B5FBD4BE0E	Ramp Type: Perp	Initial Pass/Fail: Fail	Overall Compliance: No
Severity Score: 10			
Codes/Mitigation Info/Possible Solution		Field Measurements/Component Compliance

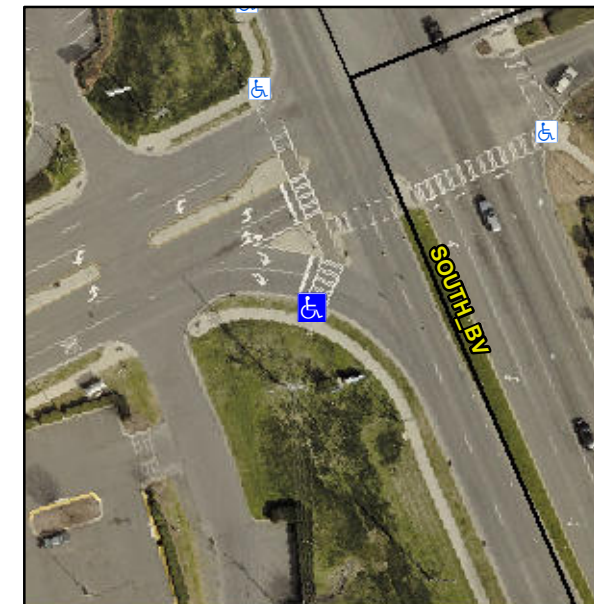
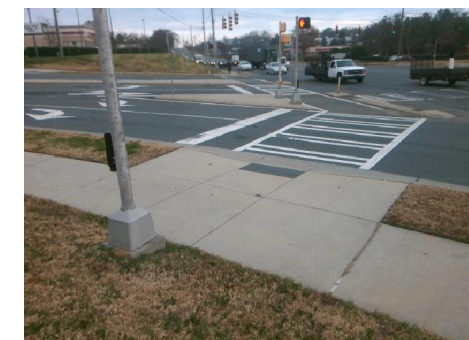
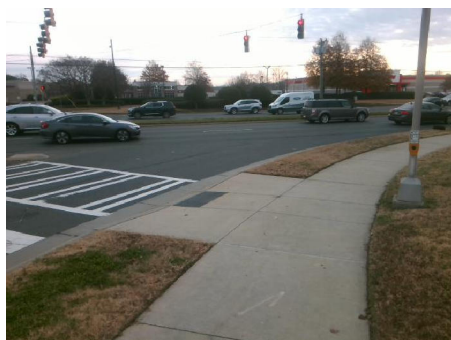
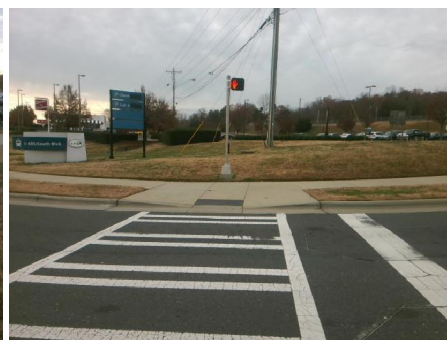
Not Found, R304.5.1, R304.5.3

Compliance	Description	Data	Compliance	Description	Data
N/A	Ramp Length (in)	71.0	Yes	Ramp Slope (%)	5.3
No	Ramp Width (in)	47.0	No	Ramp XSlope (%)	2.4
N/A	Flare Type LT	N/A	N/A	Flare Type RT	N/A
N/A	Flare Slope LT (%)	N/A	N/A	Flare Slope RT (%)	N/A
N/A	Flare Traversable LT?	N/A	N/A	Flare Traversable RT?	N/A
N/A	Landing Length (in)	N/A	N/A	DWS Provided?	N/A
N/A	Landing Width (in)	N/A	N/A	DWS Contrast?	N/A
N/A	Landing Slope (%)	N/A	N/A	DWS Length (in)	N/A
N/A	Landing X Slope (%)	N/A	N/A	DWS Full Width?	N/A
N/A	Landing Curb? (Y/N)	N/A	N/A	DWS Offset (in)	N/A
N/A	Shared Landing?	N/A			
N/A	Gutter Ponding?	N/A	N/A	Gutter Slope (%)	N/A
N/A	Gutter Lip Ht (in)	N/A	N/A	Gutter X Slope (%)	N/A
N/A	Painted X Walk1?	Yes	N/A	Painted X Walk2?	N/A
	X Walk 1 Direction	To NE		X Walk 2 Direction	N/A
N/A	X Walk 1 Width (in)	114.0	N/A	X Walk 2 Width (in)	N/A
	X Walk 1 Slope (%)	0.6		X Walk 2 Slope (%)	N/A
	X Walk 1 X Slope (%)	2.9		X Walk 2 X Slope (%)	N/A

N/A	Ramp inside XWalk1?	Yes	N/A	Ramp inside XWalk2?	N/A
	Road Slope (%)	N/A	N/A	Clear Space?	N/A
	Road X Slope (%)	N/A	N/A	Clear Space to XWalk (in)	N/A
N/A	Any Obstructions?	N/A	N/A	Storm Grate/Utility Hazard?	N/A
	Obstruction Type			Storm Grate/Utility Type	
		N/A			N/A
		Yes		Surface Condition? (G/P)	Good

Possible Solutions:

Remove & Replace Entire Ramp.
