Access Compliance Report

Public Rights-of-Way

(Curb Ramps)

| Intersection ID: 53374 | Main Street: PPC_DR | Cross Street: CRAVEN_THOMAS_RD | Location: NE |

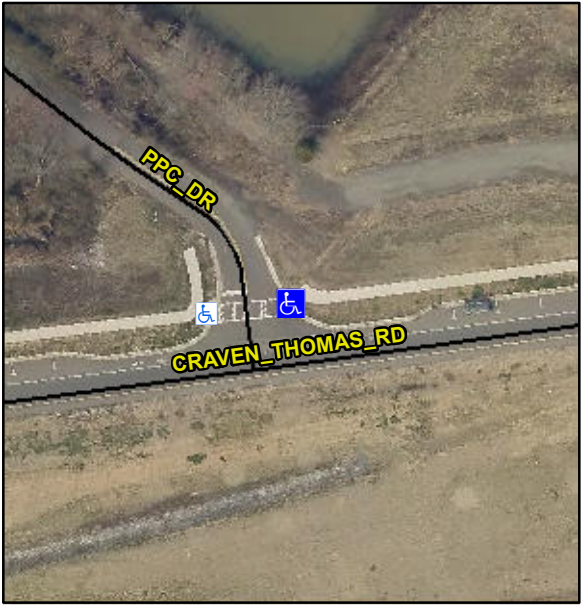
| ADA ID: 53B7A736F7D2 | Ramp Type: Perp | Initial Pass/Fail: Fail | Overall Compliance: No |

| Codes/Mitigation Info/Possible Solution | | | Field Measurements/Component Compliance | | | |
|--|--|--|---|---|---|---|
| | Remove & Replace Entire Ramp. | | No | Ramp Length (in) | 71.0 | No |
| | | | Yes | Ramp Width (in) | 48.0 | No |
| <p>Surveyor Notes:</p> <p>N/A</p> <p>PROW/ADA:</p> <p>R304.2.2, R304.5.3</p> | | | N/A | Flare Type RT | N/A | N/A |

| Codes/Mitigation Info/Possible Solution | | | Field Measurements/Component Compliance | | | |
|--|--|--|---|---|---|---|
| | Possible Solutions: | | Compliance | Description | Data | Compliance |
| <p>Total Cost:</p> <p>\$ 1850.00</p> | | | Yes | Painted X Walk1? | N/A | N/A |
