Access Compliance Report

Public Rights-of-Way

(Curb Ramps)

| Intersection ID: 45245 | Main Street: KODIAK_CT | Cross Street: BRIGHTFALLS_WY | Location: SE |

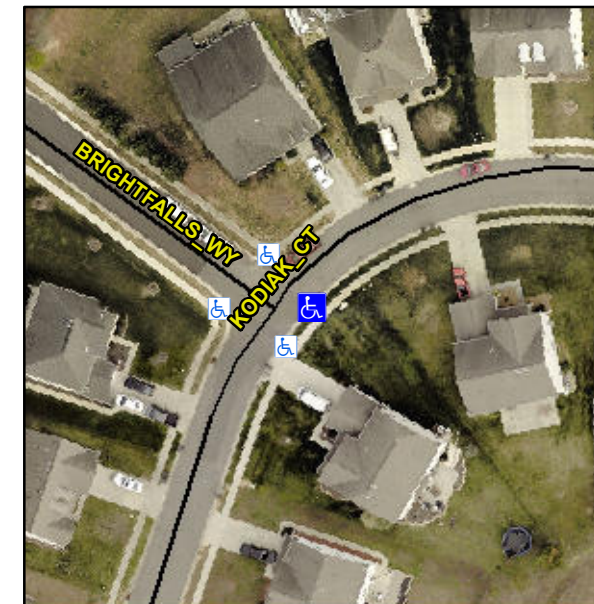
Not Found, R304.5.1, R304.2.2, R304.5.3

| Compliance | Description | Data | Compliance | Description | Data |
|---|---|---|---|---|---|
| N/A | Ramp Length (in) | 47.5 | No | Ramp Slope (%) | 10.5 |
| No | Ramp Width (in) | 47.5 | No | Ramp XSlope (%) | 3.9 |

Remove & Replace Entire Ramp.
