Intersection ID: 14085	Main Street: CARLTON_AV	Cross Street: MT_VERNON_AV	Location:	SW
ADA ID: 53C1E606ED66	Ramp Type: Perp	Initial Pass/Fail: Fail	Overall Compliance: No	Severity Score: 13.75

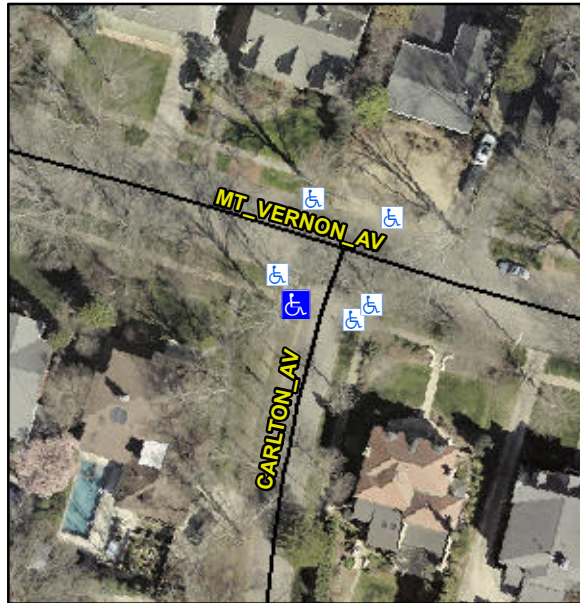
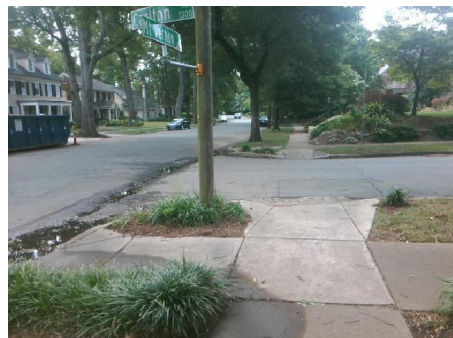
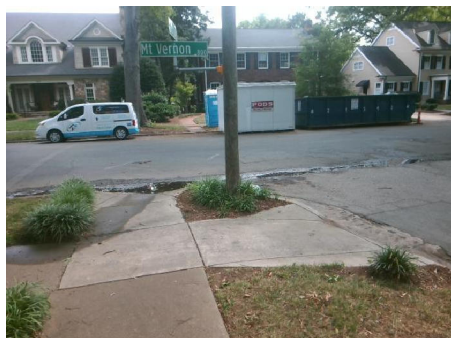
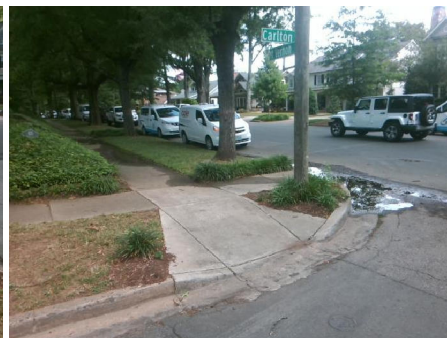
Not Found, R304.2.2, R304.5.3

Possible Solutions:			Compliance	Description	Data	Compliance	Description	Data		
Remove & Replace Entire Ramp.			N/A	Ramp Length (in)	84.0	No	Ramp Slope (%)	9.1		
			Yes	Ramp Width (in)	48.0	No	Ramp XSlope (%)	2.7		
			N/A	Flare Type LT	N/A	N/A	Flare Type RT	N/A		
			N/A	Flare Slope LT (%)	N/A	N/A	Flare Slope RT (%)	N/A		
			N/A	Flare Traversable LT?	N/A	N/A	Flare Traversable RT?	N/A		
			N/A	Landing Length (in)	N/A	N/A	DWS Provided?	N/A		
			N/A	Landing Width (in)	N/A	N/A	DWS Contrast?	N/A		
			N/A	Landing Slope (%)	N/A	N/A	DWS Length (in)	N/A		
			N/A	Landing X Slope (%)	N/A	N/A	DWS Full Width?	N/A		
			N/A	Landing Curb? (Y/N)	N/A	N/A	DWS Offset (in)	N/A		
Surveyor Notes: N/A			N/A	Shared Landing?	N/A					
			N/A	Gutter Ponding?	N/A	N/A	Gutter Slope (%)	N/A		
			N/A	Gutter Lip Ht (in)	N/A	N/A	Gutter X Slope (%)	N/A		
			N/A	Painted X Walk1?	No	N/A	Painted X Walk2?	N/A		
				X Walk 1 Direction	To SE		X Walk 2 Direction	N/A

N/A	X Walk 1 Width (in)	N/A	N/A	X Walk 2 Width (in)	N/A		
				X Walk 1 Slope (%)	0.6		X Walk 2 Slope (%)	N/A		
				X Walk 1 X Slope (%)	3.6		X Walk 2 X Slope (%)	N/A		
			N/A	Ramp inside XWalk1?	N/A	N/A	Ramp inside XWalk2?	N/A		
				Road Slope (%)	N/A	N/A	Clear Space?	N/A		
PROW/ADA: Not Found, R304.2.2, R304.5.3				Road X Slope (%)	N/A	N/A	Clear Space to XWalk (in)	N/A		
			N/A	Any Obstructions?	N/A	N/A	Storm Grate/Utility Hazard?	N/A		
				Obstruction Type			Storm Grate/Utility Type			
					N/A			N/A		
						Yes	Surface Condition? (G/P)	Good		
			Total Cost:			\$	1850.00

Possible Solutions:

Remove & Replace Entire Ramp.
