Access Compliance Report Public Rights-of-Way (Curb Ramps)

Intersection ID: 2980 Main Street: MADISON PARK DR Cross Street: MARIGOLD PL Location: Ν Initial Pass/Fail: Fail **Overall Compliance: No** ADA ID: 53C51111145F Ramp Type: Perp Severity Score: 13.75

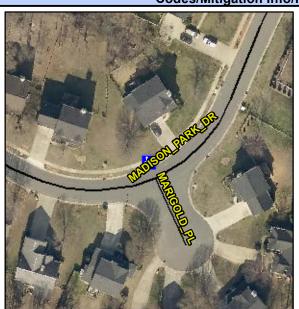
11.6

3.0

Ramp Slope (%)

Gutter X Slope (%) No N/A Painted X Walk2? N/A To S X Walk 2 Direction N/A N/A X Walk 2 Width (in) N/A X Walk 2 Slope (%) N/A 2.4 4.2 X Walk 2 X Slope (%) N/A N/A N/A Ramp inside XWalk2? N/A N/A N/A Clear Space? N/A N/A N/A Clear Space to XWalk (in) N/A N/A N/A Storm Grate/Utility Hazard? N/A Storm Grate/Utility Type N/A N/A Yes Surface Condition? (G/P) Good

MADISON PARK DR Street 1 Name Stop Condition-Street 2 None N/A Street 2 Name Stop Condition-Street 1 N/A Possible Solutions: Remove & Replace Entire Ramp. Surveyor Notes: N/A PROW/ADA: R304.2.2
