Access Compliance Report Public Rights-of-Way (Curb Ramps)

Intersection ID: 12342	Main Str	Main Street: E_8TH_ST			N_CALDWELL_ST	Location:	w			
ADA ID: 53C86A6D678D	A ID: 53C86A6D678D Ramp Type: Perp		Initial F	Initial Pass/Fail: Fail Overall Compliance: No				o Severity Score:	22.5	
Codes/Mitigation Info/Possible Solution				Field Measurements/Component Compliance

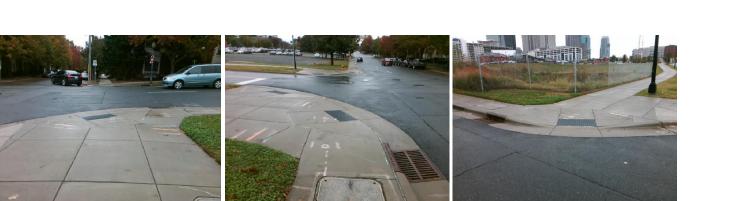
12.0	Possible Solutions:		Compliance Description			Data Compliance Description			
State of the second		Remove & Replace Entire Ram	р.	N/A	Ramp Length (in)	72.0	No	Ramp Slope (%)	9.7	
		·		No	Ramp Width (in)	47.0	No	Ramp XSlope (%)	3.5	
and the second	. m / / /			N/A	Flare Type LT	N/A	N/A	Flare Type RT	N/A	
and the second				N/A	Flare Slope LT (%)	N/A	N/A	Flare Slope RT (%)	N/A	
	FI CALL			N/A	Flare Traversable LT?	N/A	N/A	Flare Traversable RT?	N/A	
5 5 5 5 5 5 5 5 5 5 5 5 5 5 5 5 5 5 5	1 205			N/A	Landing Length (in)	N/A	N/A	DWS Provided?	N/A	
		Surveyor Notes:		N/A	Landing Width (in)	N/A	N/A	DWS Contrast?	N/A	
E States and E	<u>b.</u>	N/A		N/A	Landing Slope (%)	N/A	N/A	DWS Length (in)	N/A	
				N/A	Landing X Slope (%)	N/A	N/A	DWS Full Width?	N/A	
				N/A	Landing Curb? (Y/N)	N/A	N/A	DWS Offset (in)	N/A	
	A last			N/A	Shared Landing?	N/A				
	1 - 6	PROW/ADA:		N/A	Gutter Ponding?	N/A	N/A	Gutter Slope (%)	N/A

1 March	Not Found, R304.5.1, R304.2.2,		N/A	Gutter Lip Ht (in)	N/A	N/A	Gutter X Slope (%)	N/A	
		R304.5.3		N/A	Painted X Walk1?	No	N/A	Painted X Walk2?	N/A	
					X Walk 1 Direction	To SE		X Walk 2 Direction	N/A	
A A A A A A A A A A A A A A A A A A A				N/A	X Walk 1 Width (in)	N/A	N/A	X Walk 2 Width (in)	N/A	
Street 1 Name	N CALDWELL ST				X Walk 1 Slope (%)	2.4		X Walk 2 Slope (%)	N/A	
Stop Condition-Street 2	None				X Walk 1 X Slope (%)	0.3		X Walk 2 X Slope (%)	N/A	
Street 2 Name	N/A			N/A	Ramp inside XWalk1?	N/A	N/A	Ramp inside XWalk2?	N/A	
Stop Condition-Street 1	N/A				Road Slope (%)	N/A	N/A	Clear Space?	N/A	
					Road X Slope (%)	N/A	N/A	Clear Space to XWalk (in)	N/A	
				N/A	Any Obstructions?	N/A	N/A	Storm Grate/Utility Hazard?	N/A	
		Total Cost: \$	1850.00		Obstruction Type			Storm Grate/Utility Type		
						N/A			N/A
