Access Compliance Report Public Rights-of-Way (Curb Ramps)

Intersection ID: 2771 Main Street: MAYAPPLE_LN Cross Street: RIDGEFIELD_DR Location: W **Overall Compliance: No ADA ID: 53D8ECE728D9** Ramp Type: Perp Initial Pass/Fail: Fail **Severity Score:** 12.5

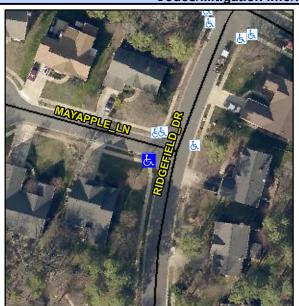
Field Measurements/Component Compliance						
Comp	oliance Description	Data	Comp	liance Description	Data	
N/A	Ramp Length (in)	49.0	No	Ramp Slope (%)	11.3	
Yes	Ramp Width (in)	48.0	Yes	Ramp XSlope (%)	0.8	
N/A	Flare Type LT	N/A	N/A	Flare Type RT	N/A	
N/A	Flare Slope LT (%)	N/A	N/A	Flare Slope RT (%)	N/A	
N/A	Flare Traversable LT?	N/A	N/A	Flare Traversable RT?	N/A	
N/A	Landing Length (in)	N/A	N/A	DWS Provided?	N/A	
N/A	Landing Width (in)	N/A	N/A	DWS Contrast?	N/A	
N/A	Landing Slope (%)	N/A	N/A	DWS Length (in)	N/A	
N/A	Landing X Slope (%)	N/A	N/A	DWS Full Width?	N/A	
N/A	Landing Curb? (Y/N)	N/A	N/A	DWS Offset (in)	N/A	
N/A	Shared Landing?	N/A				
N/A	Gutter Ponding?	N/A	N/A	Gutter Slope (%)	N/A	
N/A	Gutter Lip Ht (in)	N/A	N/A	Gutter X Slope (%)	N/A	
N/A	Painted X Walk1?	No	N/A	Painted X Walk2?	N/A	
	X Walk 1 Direction	To NE		X Walk 2 Direction	N/A	
N/A	X Walk 1 Width (in)	N/A	N/A	X Walk 2 Width (in)	N/A	
	X Walk 1 Slope (%)	2.9		X Walk 2 Slope (%)	N/A

X Walk 1 X Slope (%)	2.8		X Walk 2 X Slope (%)	N/A	
N/A	Ramp inside XWalk1?	N/A	N/A	Ramp inside XWalk2?	N/A	
	Road Slope (%)	N/A	N/A	Clear Space?	N/A	
	Road X Slope (%)	N/A	N/A	Clear Space to XWalk (in)	N/A	
N/A	Any Obstructions?	N/A	N/A	Storm Grate/Utility Hazard?	N/A	
	Obstruction Type			Storm Grate/Utility Type		
		N/A			N/A	
			Yes	Surface Condition? (G/P)	Good	
the	Y 1 25 14

Ossible Solution	
Possible Solutions:	Cor
Remove & Replace Entire Ramp.	N/A
·	Yes
	N/A
	N/A
	N/A
	N/A
Surveyor Notes:	N/A
N/A	N/A
	N/A
	N/A
	N/A
PROW/ADA:	N/A
Not Found, R304.2.2	N/A
	N/A
	N/A
	N/A

Total Cost: 1850.00
