# Access Compliance Report

## Public Rights-of-Way

### (Curb Ramps)

Intersection ID: 26115	Main Street: CARMEL_CHACE_DR	Cross Street: CARMEL_RD	Location: SW
ADA ID: 53E0C059D4BE	Ramp Type: PerpDiag	Initial Pass/Fail: Fail	Overall Compliance: No
Severity Score: 47.5			
Codes/Mitigation Info/Possible Solution		Field Measurements/Component Compliance

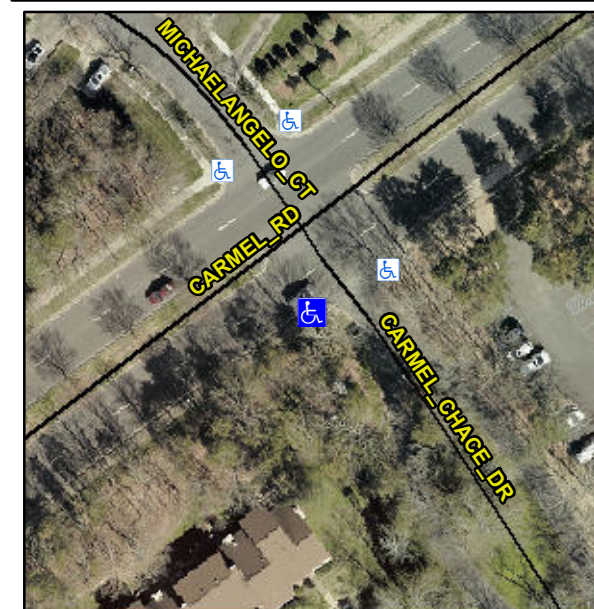
**Not Found, R304.5.1, R304.2.2**

Compliance	Description	Data	Compliance	Description	Data
N/A	Ramp Length (in)	59.0	No	Ramp Slope (%)	10.3
No	Ramp Width (in)	31.0	Yes	Ramp XSlope (%)	0.6
N/A	Flare Type LT	N/A	N/A	Flare Type RT	N/A
N/A	Flare Slope LT (%)	N/A	N/A	Flare Slope RT (%)	N/A
N/A	Flare Traversable LT?	N/A	N/A	Flare Traversable RT?	N/A
N/A	Landing Length (in)	N/A	N/A	DWS Provided?	N/A
N/A	Landing Width (in)	N/A	N/A	DWS Contrast?	N/A
N/A	Landing Slope (%)	N/A	N/A	DWS Length (in)	N/A
N/A	Landing X Slope (%)	N/A	N/A	DWS Full Width?	N/A
N/A	Landing Curb? (Y/N)	N/A	N/A	DWS Offset (in)	N/A
N/A	Shared Landing?	N/A			
N/A	Gutter Ponding?	N/A	N/A	Gutter Slope (%)	N/A
N/A	Gutter Lip Ht (in)	N/A	N/A	Gutter X Slope (%)	N/A
N/A	Painted X Walk1?	No	N/A	Painted X Walk2?	No
	X Walk 1 Direction	To E		X Walk 2 Direction	To N
N/A	X Walk 1 Width (in)	N/A	N/A	X Walk 2 Width (in)	N/A
	X Walk 1 Slope (%)	0.2		X Walk 2 Slope (%)	1.1
	X Walk 1 X Slope (%)	3.1		X Walk 2 X Slope (%)	1.7

**Remove & Replace Curb Ramp With Two New Directional Ramps or Equivalent.**
