# Access Compliance Report

## Public Rights-of-Way

### (Curb Ramps)

Intersection ID: 7094	Main Street: EQUIPMENT_DR	Cross Street: W_SUGAR_CREEK_RD	Location: NW
ADA ID: 53F88F5BE1D6	Ramp Type: Combination1	Initial Pass/Fail: Fail	Overall Compliance: No
		Severity Score: 10

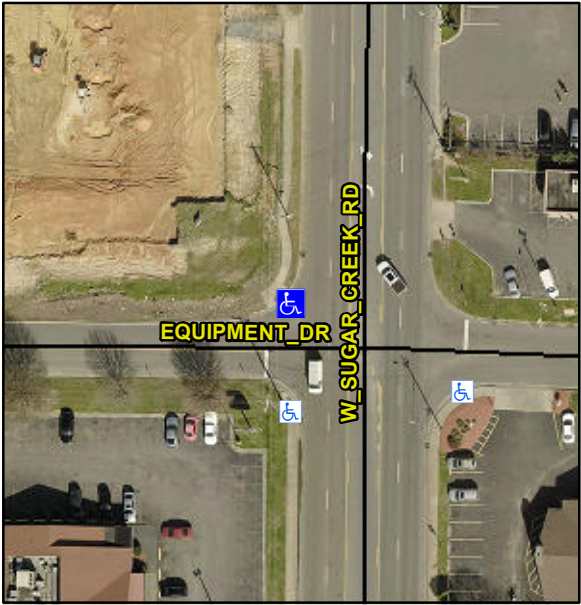
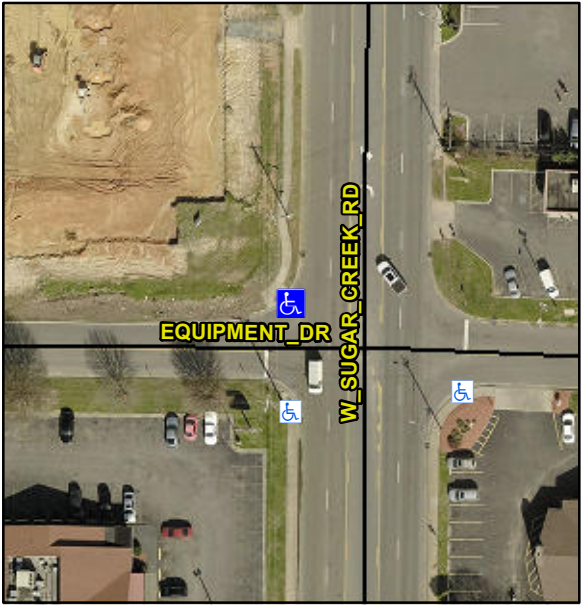
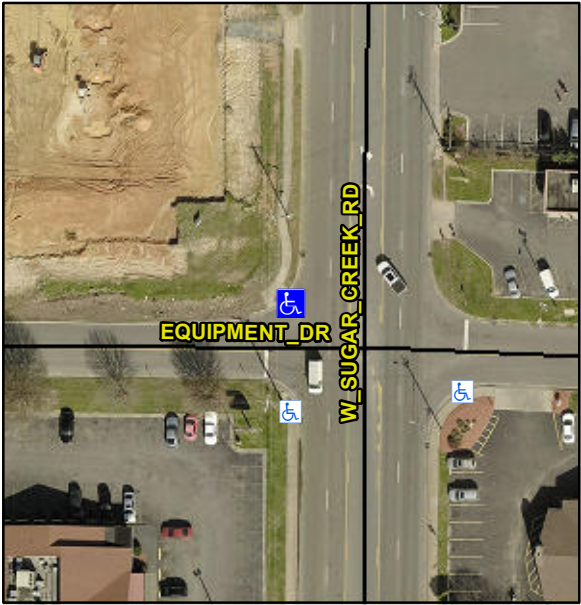
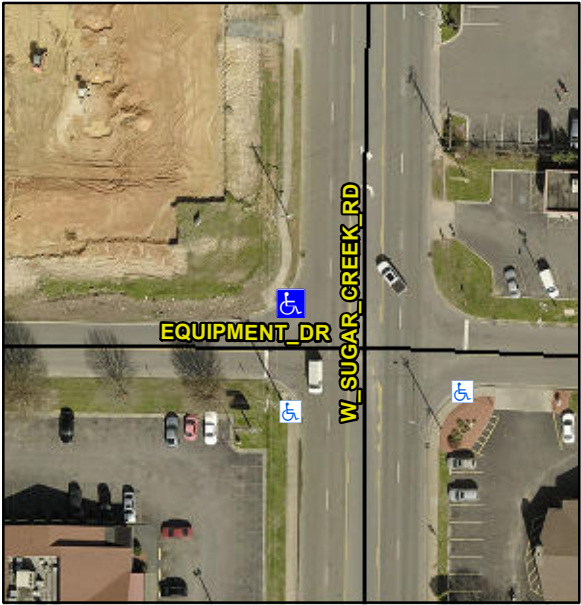
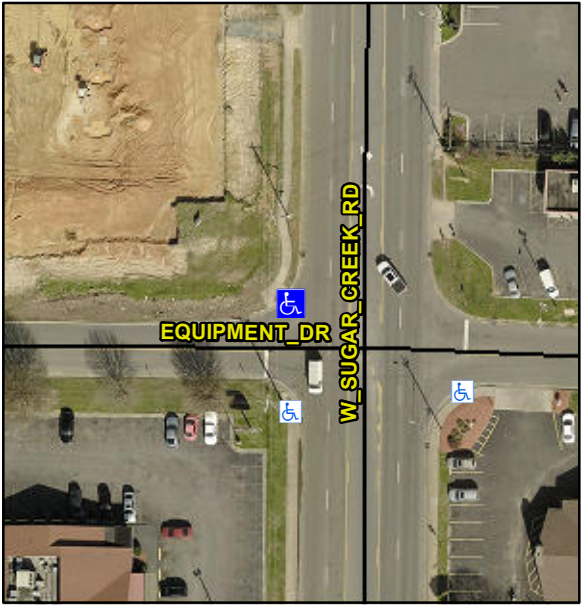
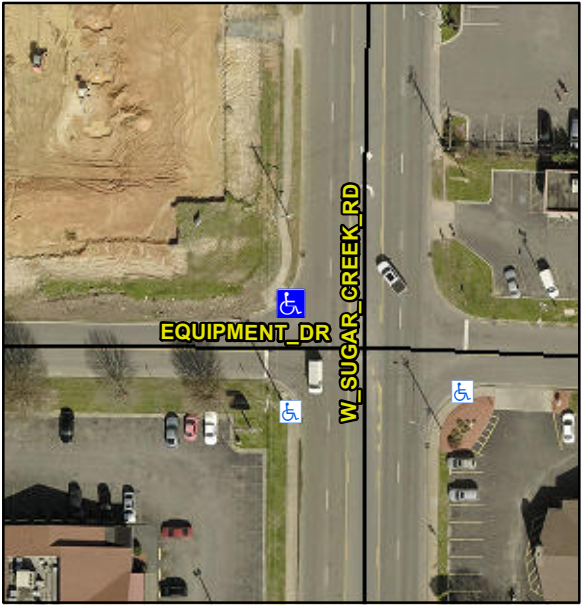
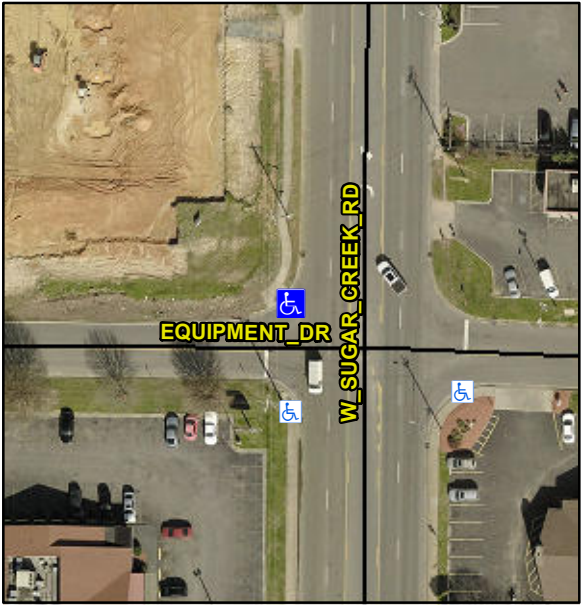
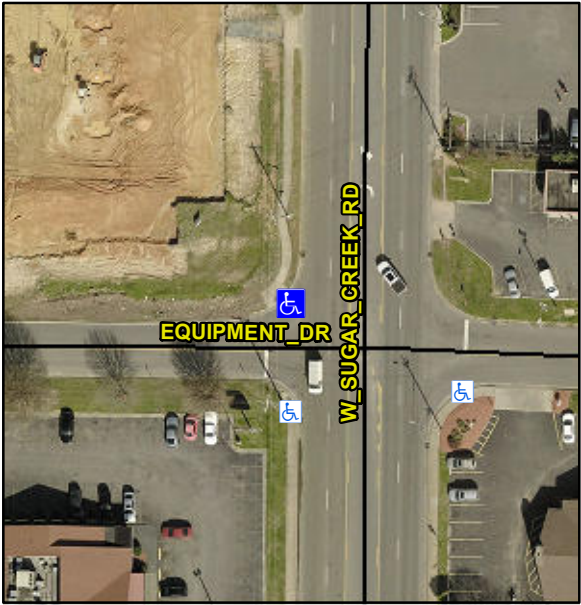
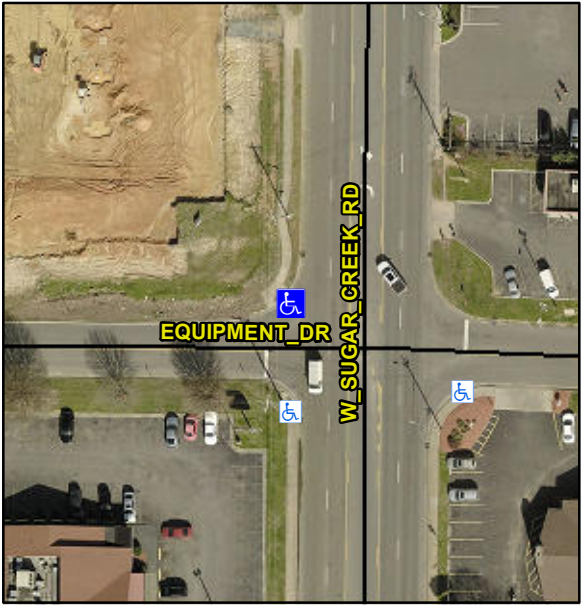
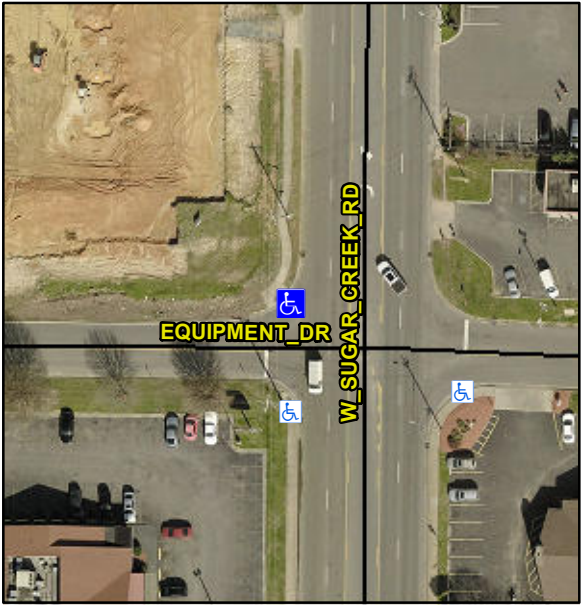
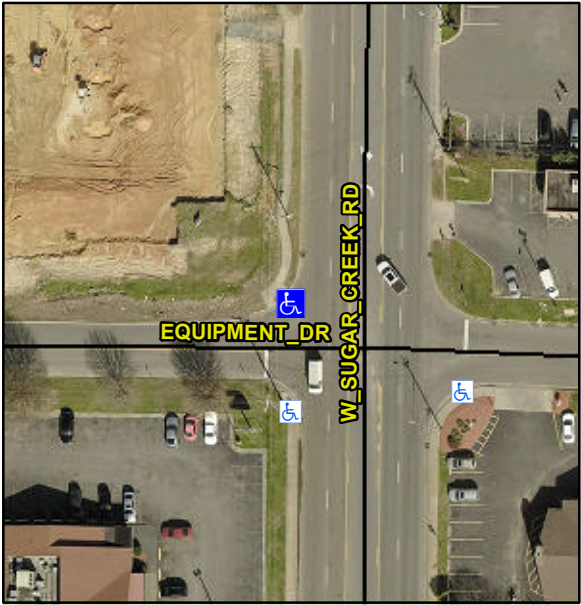
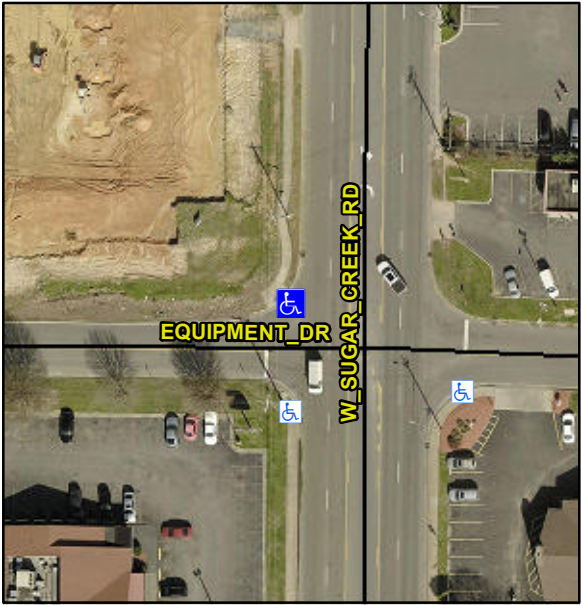
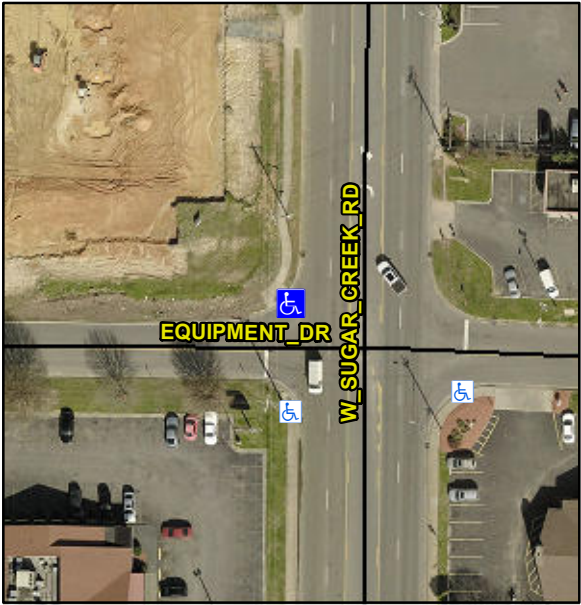
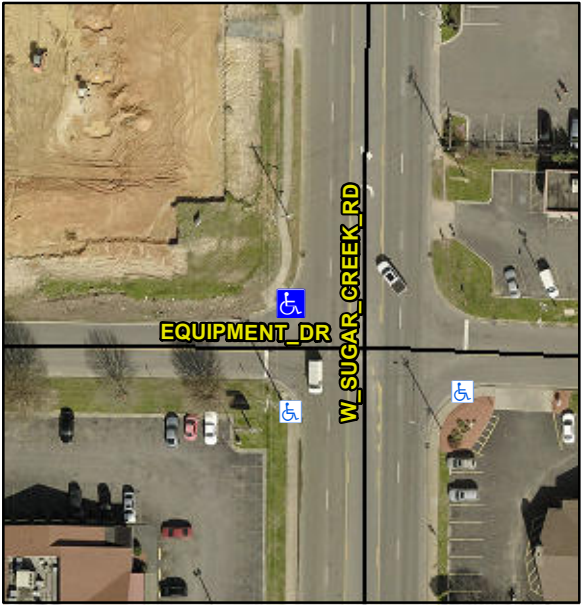
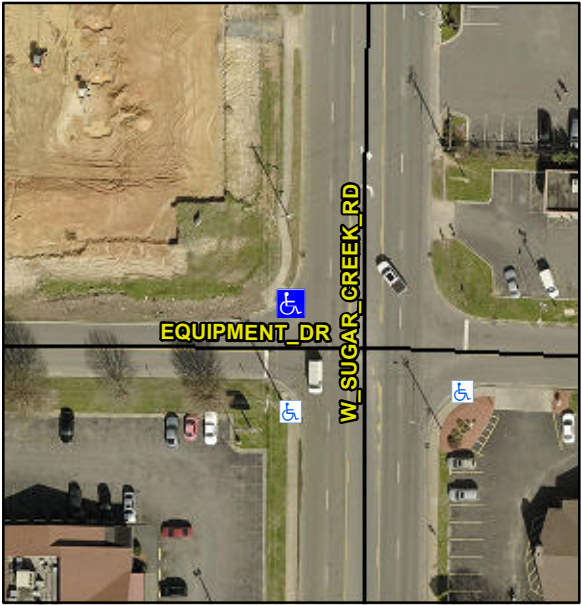
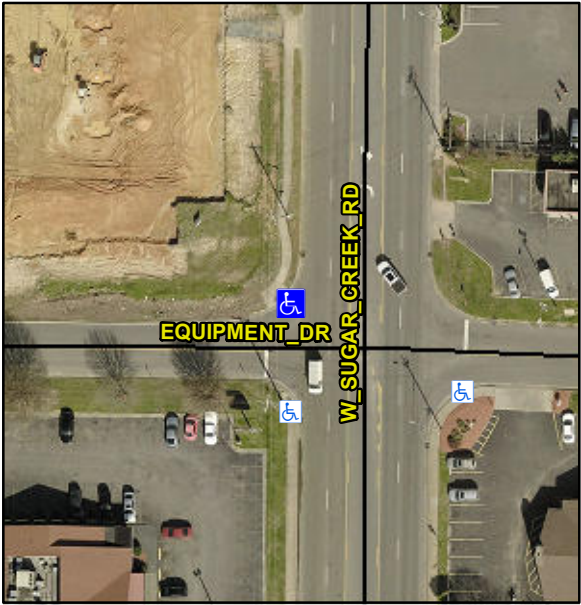
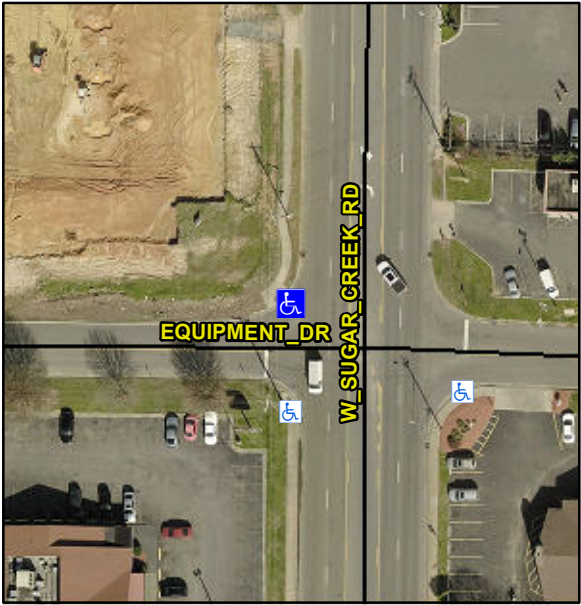
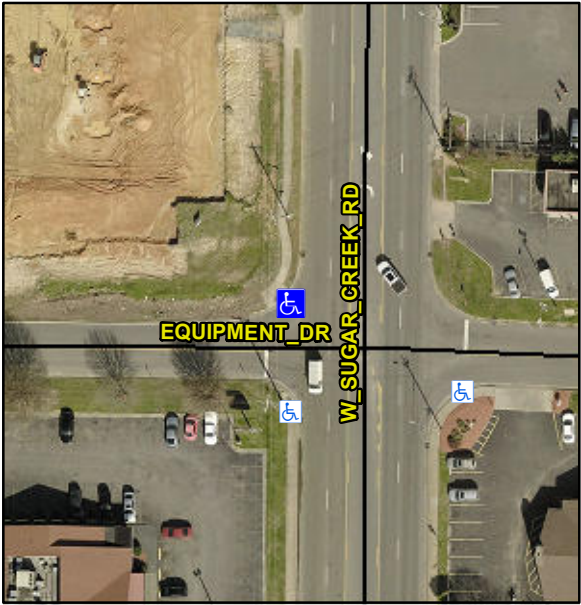
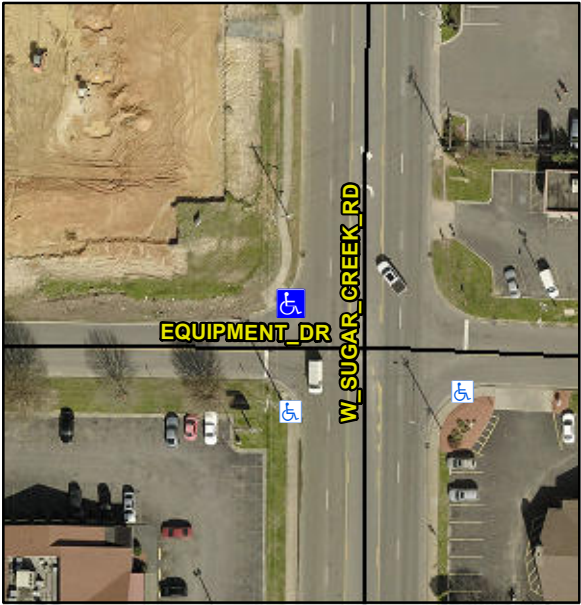
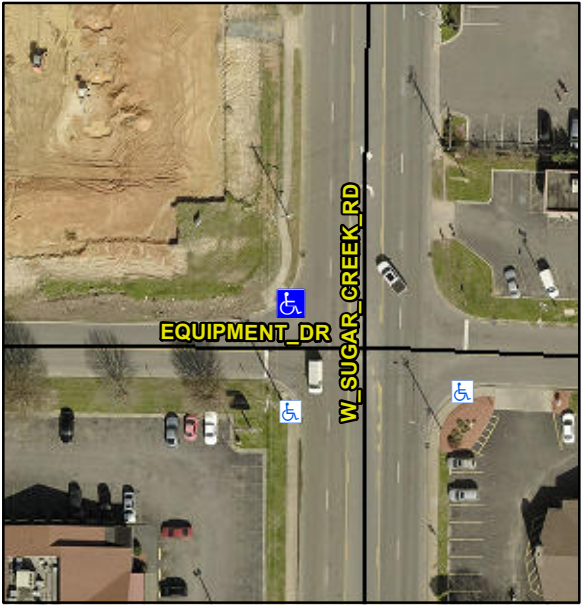
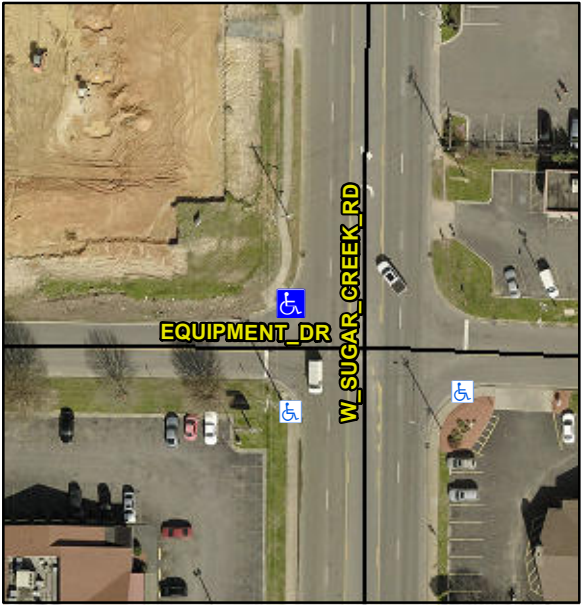
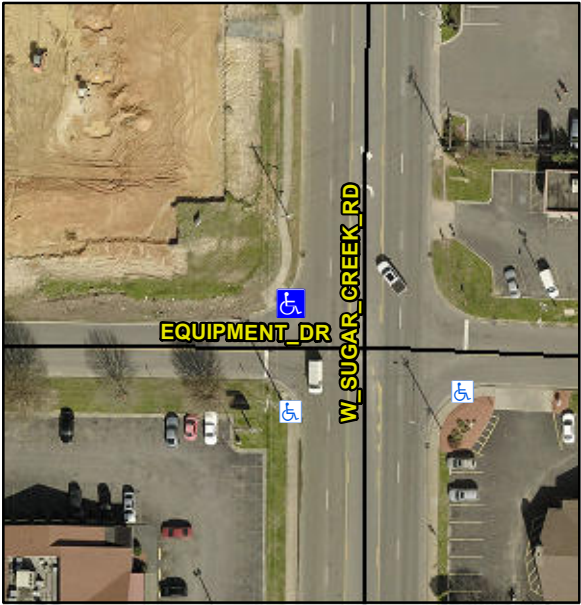
Surveyor Notes:		N/A	Ramp Length LT (in)	44.5	N/A
	<b>LT RP &lt; 5%</b>		Yes	Ramp Width LT (in)	60.0	Yes

PROW/ADA:		Yes	Ramp Slope LT (%)	1.0	Yes
	<b>Not Found, R304.5.1, R304.5.3</b>		No	Ramp XSlope LT (%)	2.4	Yes

N/A	Ramp Length (in)	48.0	Yes
			No	Ramp Width (in)	42.5	Yes

Surface Condition? (G/P)	Yes	Good
				Curb Slope (%)	15.3	15.3

Possible Solutions:		<b>Compliance</b>	<b>Description</b>	<b>Data</b>	<b>Compliance</b>
	<b>Remove &amp; Replace Entire Ramp.</b>		<b>Description</b>		<b>Data</b>	<b>Description</b>

Total Cost: \$ 1800.00
