Access Compliance Report

Public Rights-of-Way

(Curb Ramps)

Intersection ID: 30383	Main Street: BELLSOUTH_DR	Cross Street: CENTRAL_AV	Location:	N
ADA ID: 53FE49E5B73B	Ramp Type: Perp	Initial Pass/Fail: Fail	Overall Compliance: No	Severity Score: 22.5
Codes/Mitigation Info/Possible Solution		Field Measurements/Component Compliance

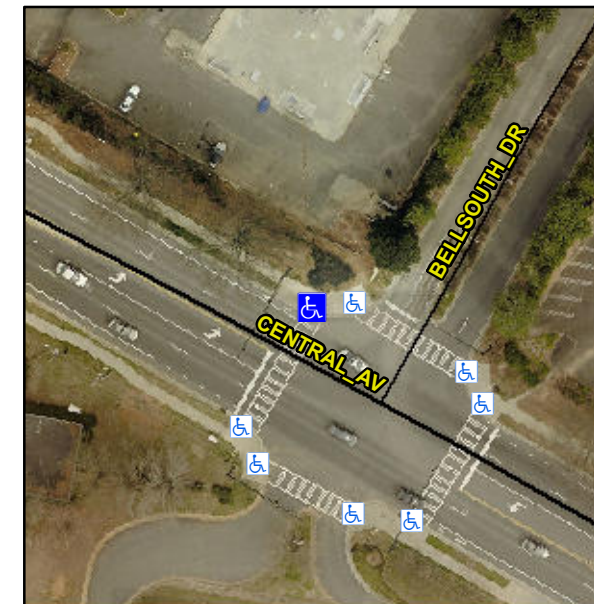
Compliance	Description	Data	Compliance	Description	Data
N/A	Ramp Length (in)	59.5	No	Ramp Slope (%)	8.7
No	Ramp Width (in)	47.5	No	Ramp XSlope (%)	3.0
N/A	Flare Type LT	N/A	N/A	Flare Type RT	N/A
N/A	Flare Slope LT (%)	N/A	N/A	Flare Slope RT (%)	N/A
N/A	Flare Traversable LT?	N/A	N/A	Flare Traversable RT?	N/A
N/A	Landing Length (in)	N/A	N/A	DWS Provided?	N/A
N/A	Landing Width (in)	N/A	N/A	DWS Contrast?	N/A
N/A	Landing Slope (%)	N/A	N/A	DWS Length (in)	N/A
N/A	Landing X Slope (%)	N/A	N/A	DWS Full Width?	N/A
N/A	Landing Curb? (Y/N)	N/A	N/A	DWS Offset (in)	N/A
N/A	Shared Landing?	N/A			
N/A	Gutter Ponding?	N/A	N/A	Gutter Slope (%)	N/A
N/A	Gutter Lip Ht (in)	N/A	N/A	Gutter X Slope (%)	N/A
N/A	Painted X Walk1?	Yes	N/A	Painted X Walk2?	N/A
	X Walk 1 Direction	To SW		X Walk 2 Direction	N/A
N/A	X Walk 1 Width (in)	112.0	N/A	X Walk 2 Width (in)	N/A
	X Walk 1 Slope (%)	4.0		X Walk 2 Slope (%)	N/A
	X Walk 1 X Slope (%)	1.6		X Walk 2 X Slope (%)	N/A

N/A	Ramp inside XWalk1?	Yes	N/A	Ramp inside XWalk2?	N/A
	Road Slope (%)	N/A	N/A	Clear Space?	N/A
	Road X Slope (%)	N/A	N/A	Clear Space to XWalk (in)	N/A
N/A	Any Obstructions?	N/A	N/A	Storm Grate/Utility Hazard?	N/A
	Obstruction Type			Storm Grate/Utility Type	
		N/A			N/A
			Yes	Surface Condition? (G/P)	Good

Possible Solutions:

Remove & Replace Entire Ramp.
