Intersection ID: 16295	Main Street: MARSH_RD	Cross Street: STONE_ORCHARD_PL	Location:	NE
ADA ID: 54051E720A6A	Ramp Type: PerpDiag	Initial Pass/Fail: Fail	Overall Compliance: No	Severity Score: 25

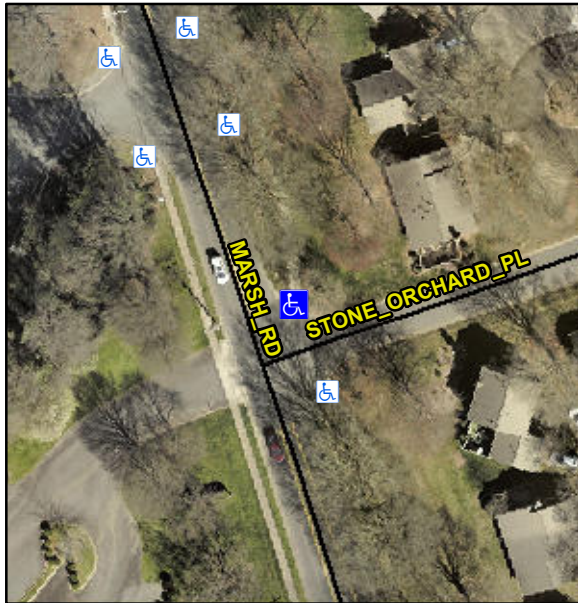
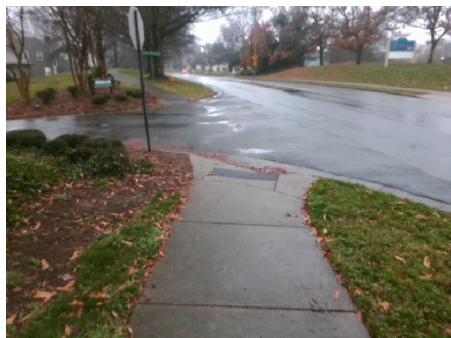
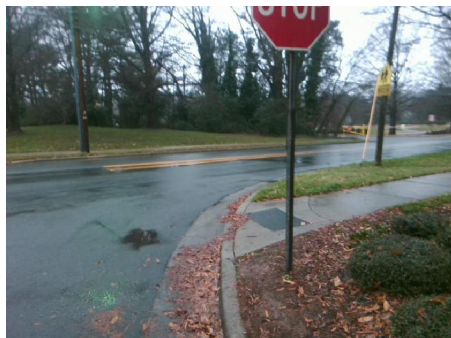
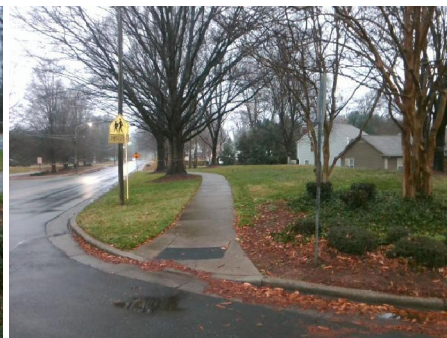
R304.2.2, R304.5.3

Compliance	Description	Data	Compliance	Description	Data
N/A	Ramp Length (in)	58.0	No	Ramp Slope (%)	9.6
Yes	Ramp Width (in)	48.0	No	Ramp XSlope (%)	6.2
N/A	Flare Type LT	N/A	N/A	Flare Type RT	N/A
N/A	Flare Slope LT (%)	N/A	N/A	Flare Slope RT (%)	N/A
N/A	Flare Traversable LT?	N/A	N/A	Flare Traversable RT?	N/A
N/A	Landing Length (in)	N/A	N/A	DWS Provided?	N/A
N/A	Landing Width (in)	N/A	N/A	DWS Contrast?	N/A
N/A	Landing Slope (%)	N/A	N/A	DWS Length (in)	N/A
N/A	Landing X Slope (%)	N/A	N/A	DWS Full Width?	N/A
N/A	Landing Curb? (Y/N)	N/A	N/A	DWS Offset (in)	N/A
N/A	Shared Landing?	N/A			
N/A	Gutter Ponding?	N/A	N/A	Gutter Slope (%)	N/A
N/A	Gutter Lip Ht (in)	N/A	N/A	Gutter X Slope (%)	N/A
N/A	Painted X Walk1?	No	N/A	Painted X Walk2?	No
	X Walk 1 Direction	To W		X Walk 2 Direction	To S
N/A	X Walk 1 Width (in)	N/A	N/A	X Walk 2 Width (in)	N/A
	X Walk 1 Slope (%)	0.5		X Walk 2 Slope (%)	2.2
	X Walk 1 X Slope (%)	2.3		X Walk 2 X Slope (%)	0.8

N/A	Ramp inside XWalk1?	N/A	N/A	Ramp inside XWalk2?	N/A
	Road Slope (%)	2.5	N/A	Clear Space?	N/A
	Road X Slope (%)	1.9	N/A	Clear Space to XWalk (in)	N/A
N/A	Any Obstructions?	N/A	N/A	Storm Grate/Utility Hazard?	N/A
	Obstruction Type			Storm Grate/Utility Type	
		N/A			N/A
			Yes	Surface Condition? (G/P)	Good

Remove & Replace Curb Ramp With Two New Directional Ramps or Equivalent.
