Access Compliance Report Public Rights-of-Way (Curb Ramps)

Intersection ID: 14135 Main Street: CHESTERFIELD AV **Cross Street: HANOVER ST** Location: Ν

Initial Pass/Fail: Fail **Overall Compliance: No** ADA ID: 540B8D8B2D29 Ramp Type: Perp Severity Score: 13.75

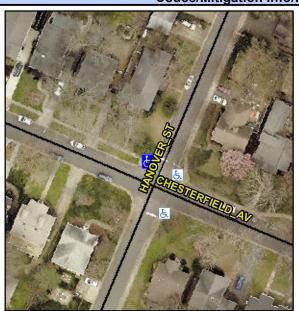
Compliance Description <u>Data</u> Compliance Description Data No N/A Ramp Length (in) 58.0 Ramp Slope (%) 10.2 No Yes Ramp Width (in) 83.0 Ramp XSlope (%) 2.8 N/A N/A Flare Type LT N/A Flare Type RT N/A N/A N/A N/A Flare Slope RT (%) N/A Flare Slope LT (%) N/A Flare Traversable LT? N/A N/A Flare Traversable RT? N/A N/A N/A N/A **DWS Provided?** N/A Landing Length (in) N/A Landing Width (in) N/A N/A **DWS Contrast?** N/A N/A N/A N/A Landing Slope (%) DWS Length (in) N/A N/A Landing X Slope (%) N/A N/A DWS Full Width? N/A N/A Landing Curb? (Y/N) N/A N/A DWS Offset (in) N/A N/A N/A Shared Landing? N/A **Gutter Ponding?** N/A N/A Gutter Slope (%) N/A N/A Gutter Lip Ht (in) 1.0 N/A Gutter X Slope (%) N/A N/A Painted X Walk1? No N/A Painted X Walk2? N/A X Walk 1 Direction To SE X Walk 2 Direction N/A N/A N/A N/A X Walk 1 Width (in) X Walk 2 Width (in) N/A X Walk 1 Slope (%) 0.3 X Walk 2 Slope (%) N/A X Walk 1 X Slope (%) 4.0 X Walk 2 X Slope (%) N/A N/A N/A N/A Ramp inside XWalk2? Ramp inside XWalk1? N/A Road Slope (%) N/A N/A Clear Space? N/A Road X Slope (%) N/A N/A Clear Space to XWalk (in) N/A N/A N/A Any Obstructions? N/A Storm Grate/Utility Hazard? N/A **Obstruction Type** Storm Grate/Utility Type N/A

HANOVER ST Street 1 Name Stop Condition-Street 2 StopSign N/A Street 2 Name Stop Condition-Street 1 N/A Possible Solutions: Remove & Replace Entire Ramp. Surveyor Notes: N/A PROW/ADA: Not Found, R304.2.2, R304.5.3
