Access Compliance Report

Public Rights-of-Way

(Curb Ramps)

Intersection ID: 15013	Main Street: E_WORTHINGTON_AV	Cross Street: EWING_AV	Location: N
ADA ID: 541DFE550EBD	Ramp Type: Perp	Initial Pass/Fail: Fail	Overall Compliance: No
Severity Score: 33.75			
Codes/Mitigation Info/Possible Solution		Field Measurements/Component Compliance

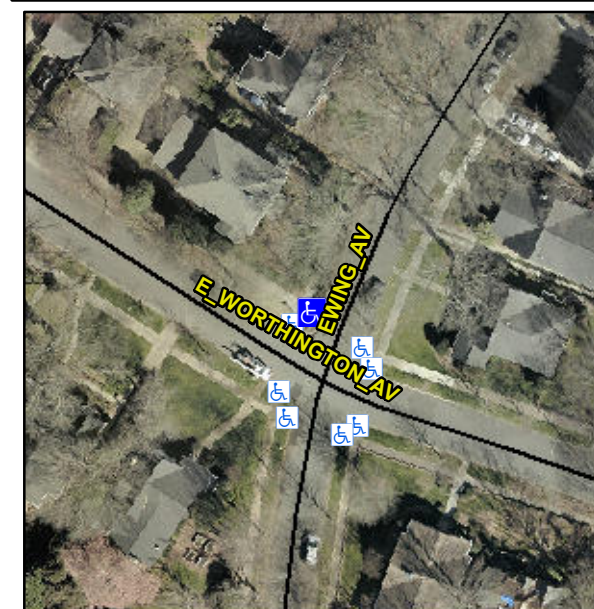
Not Found, R304.5.1, R304.2.2, R304.5.3

Compliance	Description	Data	Compliance	Description	Data
N/A	Ramp Length (in)	82.0	No	Ramp Slope (%)	9.5
No	Ramp Width (in)	36.0	No	Ramp XSlope (%)	5.2
N/A	Flare Type LT	N/A	N/A	Flare Type RT	N/A
N/A	Flare Slope LT (%)	N/A	N/A	Flare Slope RT (%)	N/A
N/A	Flare Traversable LT?	N/A	N/A	Flare Traversable RT?	N/A
N/A	Landing Length (in)	N/A	N/A	DWS Provided?	N/A
N/A	Landing Width (in)	N/A	N/A	DWS Contrast?	N/A
N/A	Landing Slope (%)	N/A	N/A	DWS Length (in)	N/A
N/A	Landing X Slope (%)	N/A	N/A	DWS Full Width?	N/A
N/A	Landing Curb? (Y/N)	N/A	N/A	DWS Offset (in)	N/A
N/A	Shared Landing?	N/A			
N/A	Gutter Ponding?	N/A	N/A	Gutter Slope (%)	N/A
N/A	Gutter Lip Ht (in)	1.0	N/A	Gutter X Slope (%)	N/A
N/A	Painted X Walk1?	No	N/A	Painted X Walk2?	N/A
	X Walk 1 Direction	To SE		X Walk 2 Direction	N/A
N/A	X Walk 1 Width (in)	N/A	N/A	X Walk 2 Width (in)	N/A
	X Walk 1 Slope (%)	1.4		X Walk 2 Slope (%)	N/A
	X Walk 1 X Slope (%)	0.9		X Walk 2 X Slope (%)	N/A

N/A	Ramp inside XWalk1?	N/A	N/A	Ramp inside XWalk2?	N/A
	Road Slope (%)	N/A	N/A	Clear Space?	N/A
	Road X Slope (%)	N/A	N/A	Clear Space to XWalk (in)	N/A
N/A	Any Obstructions?	N/A	N/A	Storm Grate/Utility Hazard?	N/A
	Obstruction Type			Storm Grate/Utility Type	
		N/A			N/A
			Yes	Surface Condition? (G/P)	Good

Possible Solutions:

Remove & Replace Entire Ramp.

Total Cost: \$ 1850.00
