Access Compliance Report Public Rights-of-Way (Curb Ramps)

Intersection ID: 49292 Main Street: ROYAL_WINCHESTER_DR			Cross	oss Street: CHAMBERLIN_RD				Location:	S
ADA ID: 542335A2D37A Ramp Type: PerpDiag			Initial	itial Pass/Fail: Pass Overall Compliance: No				o Severity Score:	7.5
Codes/Mitigation Info/Possible Solution				Field Measurements/Component Compliance					
		Possible Solutions:		Compliance Description		Data	Data Compliance Description		Data
		Remove & Replace Curb Ramp Wi Two New Directional Ramps or Equivalent. Grind Gutter Lip.	With	N/A	Ramp Length (in)	78.0	Yes	Ramp Slope (%)	8.0

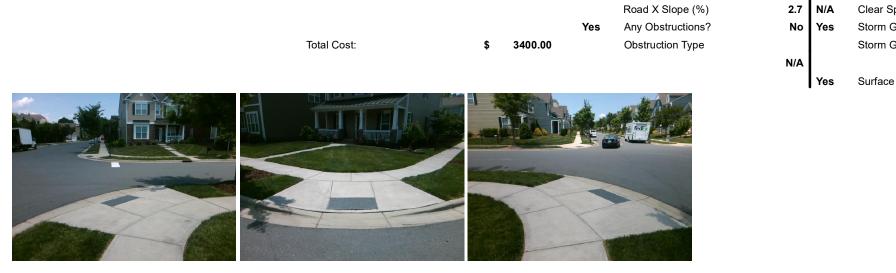
•	Yes	Ramp Width (in)	48.0	Yes	Ramp XSlope (%)	0.8
				N/A	Flare Type LT	Sloped	N/A	Flare Type RT	N/A
				N/A	Flare Slope LT (%)	7.9	Yes	Flare Slope RT (%)	6.7
				N/A	Flare Traversable LT?	Yes	N/A	Flare Traversable RT?	Yes

6. 20				No	Landing Length (in)	41.0	Yes	DWS Provided?	Yes
A Star		Surveyor Notes:		Yes	Landing Width (in)	48.0	Yes	DWS Contrast?	Yes
	t.	N/A		No	Landing Slope (%)	3.9	Yes	DWS Length (in)	24.0
PROW/ADA: R304.2.1, R304.2.2-Perp, R304.3.2- Para, R305.2, R302.7.2				Yes	Landing X Slope (%)	1.5	Yes	DWS Full Width?	Yes
				N/A	Landing Curb? (Y/N)	No	No	DWS Offset (in)	5.0
				N/A	Shared Landing?	No			
				Yes	Gutter Ponding?	No	Yes	Gutter Slope (%)	0.0

3.2-	No	Gutter Lip Ht (in)	0.5	Yes	Gutter X Slope (%)	0.4
			-	N/A	Painted X Walk1?	No	N/A	Painted X Walk2?	No
					X Walk 1 Direction	To NE		X Walk 2 Direction	To NW
				N/A	X Walk 1 Width (in)	N/A	N/A	X Walk 2 Width (in)	N/A
Street 1 Name	ROYAL WINCHESTER DR				X Walk 1 Slope (%)	2.4		X Walk 2 Slope (%)	3.1
Stop Condition-Street 2	StopSign				X Walk 1 X Slope (%)	2.6		X Walk 2 X Slope (%)	1.3
Street 2 Name	CHAMBERLIN RD			N/A	Ramp inside XWalk1?	N/A	N/A	Ramp inside XWalk2?	N/A
Stop Condition-Street 1	None				Road Slope (%)	0.7	N/A	Clear Space?	Yes
					Road X Slope (%)	2.7	N/A	Clear Space to XWalk (in)	N/A
				Yes	Any Obstructions?	No	Yes	Storm Grate/Utility Hazard?	No
		Total Cost: \$	3400.00		Obstruction Type			Storm Grate/Utility Type	
						N/A			N/A

s Surface Condition? (G/P) Good
