Access Compliance Report Public Rights-of-Way (Curb Ramps)

Intersection ID: 14477 Main Street: WEDDINGTON_AV Cross Street: BASCOM_ST Location: N

ADA ID: 5430B9F82660 Ramp Type: PerpDiag Initial Pass/Fail: Fail Overall Compliance: No Severity Score: 30

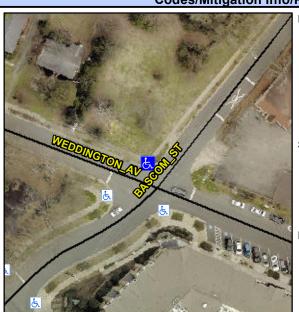
Field Measurements/Component Compliance							
	Compliance Description		Data	Compliance Description		Description	Data
	N/A	Ramp Length (in)	103.0	No	Ramp	Slope (%)	8.6
	No	Ramp Width (in)	34.0	Yes	Ramp	XSlope (%)	0.2
	N/A	Flare Type LT	N/A	N/A	Flare 1	ype RT	N/A
	N/A	Flare Slope LT (%)	N/A	N/A	Flare S	Slope RT (%)	N/A
	N/A	Flare Traversable LT?	N/A	N/A	Flare 1	raversable RT?	N/A
	N/A	Landing Length (in)	N/A	N/A	DWS I	Provided?	N/A
	N/A	Landing Width (in)	N/A	N/A	DWS (Contrast?	N/A
	N/A	Landing Slope (%)	N/A	N/A	DWS I	ength (in)	N/A
	N/A	Landing X Slope (%)	N/A	N/A	DWS I	Full Width?	N/A
	N/A	Landing Curb? (Y/N)	N/A	N/A	DWS (Offset (in)	N/A
	N/A	Shared Landing?	N/A				
	N/A	Gutter Ponding?	N/A	N/A	Gutter	Slope (%)	N/A
	N/A	Gutter Lip Ht (in)	N/A	N/A	Gutter	X Slope (%)	N/A
	N/A	Painted X Walk1?	No	N/A	Painte	d X Walk2?	No
		X Walk 1 Direction	To SW		X Wall	2 Direction	To SE
	N/A	X Walk 1 Width (in)	N/A	N/A	X Wall	(2 Width (in)	N/A

X Walk 1 Slope (%)	4.3		X Wall	(2 Slope (%)	0.0
		X Walk 1 X Slope (%)	0.3		X Wall	(2 X Slope (%)	0.8
	N/A	Ramp inside XWalk1?	N/A	N/A	Ramp	inside XWalk2?	N/A
		Road Slope (%)	4.5	N/A	Clear	Space?	N/A
		Road X Slope (%)	3.0	N/A	Clear	Space to XWalk (in)	N/A
	N/A	Any Obstructions?	N/A	N/A	Storm	Grate/Utility Hazard?	N/A
		Obstruction Type			Storm	Grate/Utility Type	
			N/A				N/A
				Yes	Surfac	e Condition? (G/P)	Good

Remove & Replace Curb Ramp With Two New Directional Ramps or Equivalent.

R304.5.1, R304.2.2
