# Access Compliance Report

## Public Rights-of-Way

### (Curb Ramps)

Intersection ID: 3565	Main Street: ROTHERHAM_LN	Cross Street: TREYBURN_DR	Location: N
ADA ID: 54360CF6AE96	Ramp Type: Perp	Initial Pass/Fail: Fail	Overall Compliance: No
			Severity Score: 13.75

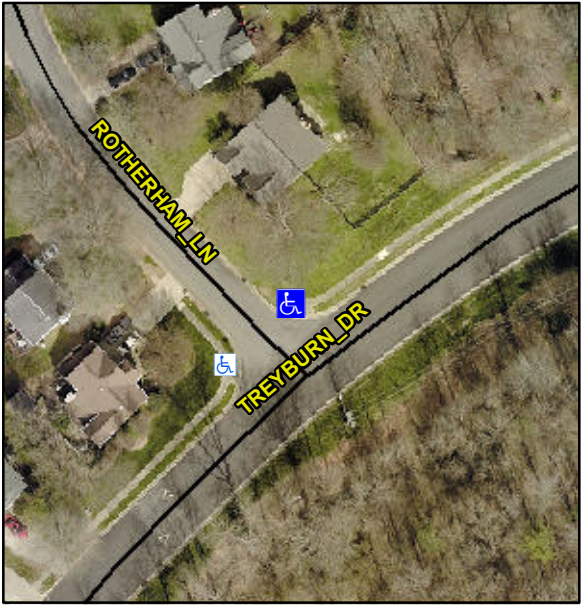
Possible Solutions:		<b>Compliance</b>	<b>Description</b>	<b>Data</b>
	<b>Remove &amp; Replace Entire Ramp.</b>		<b>No</b>	Ramp Length (in)	<b>95.0</b>
			<b>Yes</b>	Ramp Width (in)	<b>48.0</b>
			<b>N/A</b>	Flare Type LT	<b>N/A</b>
			<b>N/A</b>	Flare Slope LT (%)	<b>N/A</b>
			<b>N/A</b>	Flare Traversable LT?	<b>N/A</b>
			<b>N/A</b>	Landing Length (in)	<b>N/A</b>
			<b>N/A</b>	Landing Width (in)	<b>N/A</b>
			<b>N/A</b>	Landing Slope (%)	<b>N/A</b>
			<b>N/A</b>	Landing X Slope (%)	<b>N/A</b>
<p>Surveyor Notes:</p> <p><b>N/A</b></p> <p>PROW/ADA:</p> <p><b>Not Found, R304.2.2, R304.5.3</b></p>			<b>N/A</b>	Flare Type RT	<b>N/A</b>
			<b>N/A</b>	Flare Slope RT (%)	<b>N/A</b>
			<b>N/A</b>	Flare Traversable RT?	<b>N/A</b>
			<b>N/A</b>	DWS Provided?	<b>N/A</b>
			<b>N/A</b>	DWS Contrast?	<b>N/A</b>
			<b>N/A</b>	DWS Length (in)	<b>N/A</b>

<b>N/A</b>	DWS Full Width?	<b>N/A</b>
			<b>N/A</b>	DWS Offset (in)	<b>N/A</b>
			<b>N/A</b>	Gutter Ponding?	<b>N/A</b>
			<b>N/A</b>	Gutter Lip Ht (in)	<b>N/A</b>
<p>Total Cost:</p> <p><b>\$ 1850.00</b></p>			<b>No</b>	Painted X Walk2?	<b>N/A</b>
			<b>To SW</b>	X Walk 2 Direction	<b>N/A</b>
			<b>N/A</b>	X Walk 2 Width (in)	<b>N/A</b>
			<b>0.2</b>	X Walk 2 Slope (%)	<b>N/A</b>
			<b>0.7</b>	X Walk 2 X Slope (%)	<b>N/A</b>
			<b>N/A</b>	Ramp inside XWalk2?	<b>N/A</b>
			<b>N/A</b>	Clear Space?	<b>N/A</b>
			<b>N/A</b>	Clear Space to XWalk (in)	<b>N/A</b>
			<b>N/A</b>	Storm Grate/Utility Hazard?	<b>N/A</b>
			<b>N/A</b>	Storm Grate/Utility Type	<b>N/A</b>
			<b>N/A</b>		<b>N/A</b>
			<b>Yes</b>	Surface Condition? (G/P)	<b>Good</b>
