# Access Compliance Report

## Public Rights-of-Way

### (Curb Ramps)

Intersection ID: 47610	Main Street: BATHURST_DR	Cross Street: MINTWORTH_AV	Location: NE
ADA ID: 543EE2104621	Ramp Type: PerpDiag	Initial Pass/Fail: Fail	Overall Compliance: No
		Severity Score: 12.5

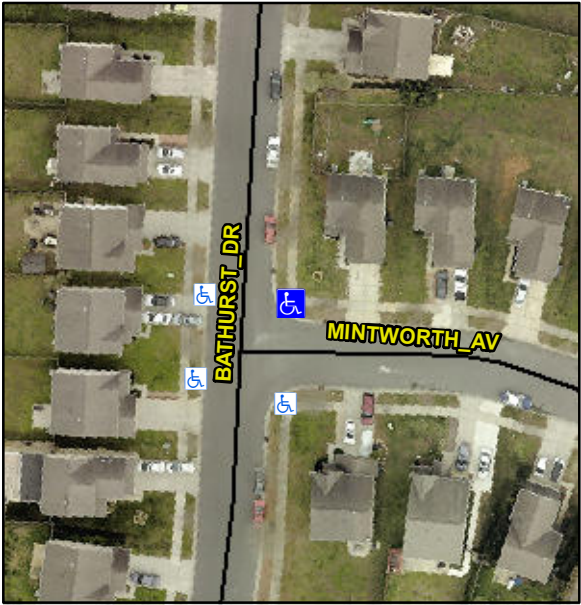
Possible Solutions:		<b>Compliance</b>	<b>Description</b>	<b>Data</b>
	<b>Remove &amp; Replace Curb Ramp With Two New Directional Ramps or Equivalent.</b>		<b>No</b>	Ramp Length (in)	69.0
			<b>Yes</b>	Ramp Width (in)	48.0
			<b>N/A</b>	Flare Type LT	N/A
			<b>N/A</b>	Flare Slope LT (%)	N/A
			<b>N/A</b>	Flare Traversable LT?	N/A
			<b>N/A</b>	Landing Length (in)	N/A
			<b>N/A</b>	Landing Width (in)	N/A
			<b>N/A</b>	Landing Slope (%)	N/A
			<b>N/A</b>	Landing X Slope (%)	N/A
<p>Surveyor Notes:</p> <p><b>N/A</b></p> <p>PROW/ADA:</p> <p><b>R304.2.2</b></p>			<b>N/A</b>	Flare Type RT	N/A
			<b>N/A</b>	Flare Slope RT (%)	N/A
			<b>N/A</b>	Flare Traversable RT?	N/A
			<b>N/A</b>	DWS Provided?	N/A
			<b>N/A</b>	DWS Contrast?	N/A
			<b>N/A</b>	DWS Length (in)	N/A
			<b>N/A</b>	DWS Full Width?	N/A
			<b>N/A</b>	DWS Offset (in)	N/A

<b>N/A</b>	Gutter Ponding?	N/A
			<b>N/A</b>	Gutter Lip Ht (in)	N/A
			<b>No</b>	Painted X Walk1?	N/A
			<b>To NW</b>	X Walk 1 Direction	To SW
			<b>N/A</b>	X Walk 1 Width (in)	N/A
			<b>2.3</b>	X Walk 1 Slope (%)	0.9
			<b>1.4</b>	X Walk 1 X Slope (%)	1.1
			<b>N/A</b>	Ramp inside XWalk1?	N/A
			<b>1.3</b>	Road Slope (%)	N/A
			<b>2.2</b>	Road X Slope (%)	N/A
			<b>N/A</b>	Any Obstructions?	N/A
			<b>N/A</b>	Obstruction Type	N/A
Total Cost:		\$ 3200.00	<b>N/A</b>	Clear Space?	N/A
			<b>N/A</b>	Clear Space to XWalk (in)	N/A
			<b>N/A</b>	Storm Grate/Utility Hazard?	N/A
			<b>N/A</b>	Storm Grate/Utility Type	N/A
			<b>Yes</b>	Surface Condition? (G/P)	Good
