Intersection ID: 10033935	Main Street: PARK_RD	Cross Street: N/A	Location:	SW
ADA ID: 54516E8C0D54	Ramp Type: Perp	Initial Pass/Fail: Fail	Overall Compliance: No	Severity Score: 46.25

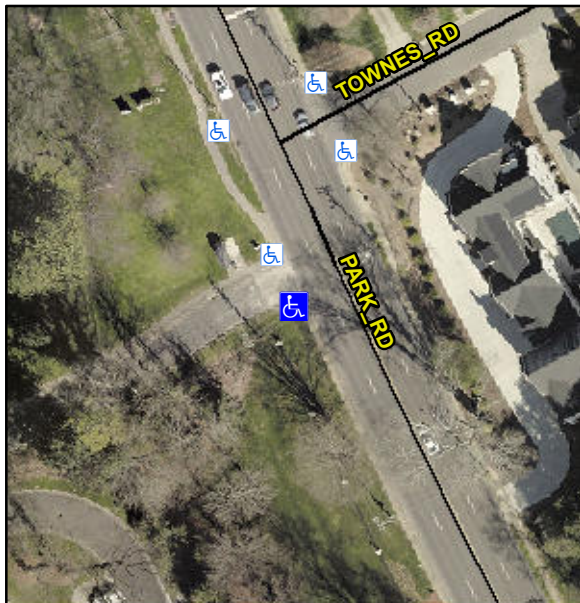
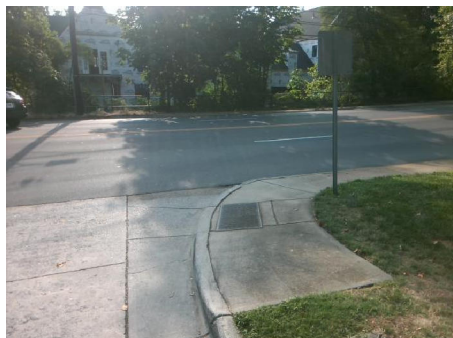
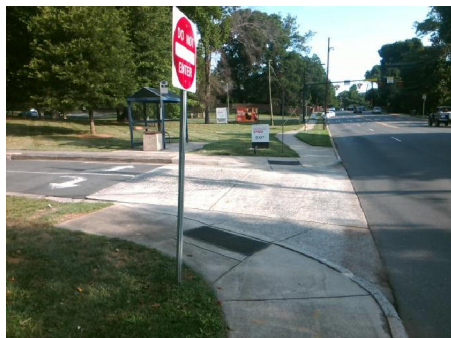
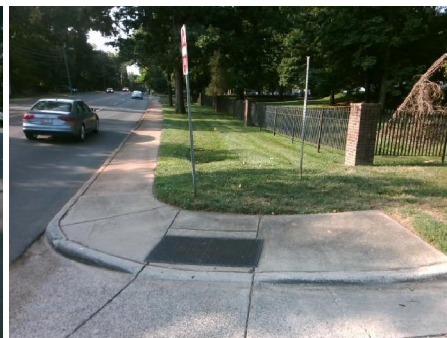
Possible Solutions:		Compliance	Description	Data	Compliance	Description	Data
	Remove & Replace Entire Ramp.		N/A	Ramp Length (in)	58.0	No	Ramp Slope (%)	10.1
			No	Ramp Width (in)	45.0	No	Ramp XSlope (%)	9.1
			N/A	Flare Type LT	N/A	N/A	Flare Type RT	N/A
			N/A	Flare Slope LT (%)	N/A	N/A	Flare Slope RT (%)	N/A
			N/A	Flare Traversable LT?	N/A	N/A	Flare Traversable RT?	N/A
			N/A	Landing Length (in)	N/A	N/A	DWS Provided?	N/A
			N/A	Landing Width (in)	N/A	N/A	DWS Contrast?	N/A
			N/A	Landing Slope (%)	N/A	N/A	DWS Length (in)	N/A
			N/A	Landing X Slope (%)	N/A	N/A	DWS Full Width?	N/A
Surveyor Notes:		N/A	N/A	Landing Curb? (Y/N)	N/A	N/A	DWS Offset (in)	N/A
PROW/ADA:		R304.5.1, R304.2.2, R304.5.3	N/A	Shared Landing?	N/A	N/A		
			N/A	Gutter Ponding?	N/A	N/A	Gutter Slope (%)	N/A
			N/A	Gutter Lip Ht (in)	1.0	N/A	Gutter X Slope (%)	N/A

N/A	Painted X Walk1?	No	N/A	Painted X Walk2?	N/A
				X Walk 1 Direction	To NW		X Walk 2 Direction	N/A
			N/A	X Walk 1 Width (in)	N/A	N/A	X Walk 2 Width (in)	N/A
				X Walk 1 Slope (%)	0.7		X Walk 2 Slope (%)	N/A
				X Walk 1 X Slope (%)	4.9		X Walk 2 X Slope (%)	N/A
Street 1 Name		ENTRANCE	N/A	Ramp inside XWalk1?	N/A	N/A	Ramp inside XWalk2?	N/A
Stop Condition-Street 2		StopSign	N/A	Road Slope (%)	N/A	N/A	Clear Space?	N/A
Street 2 Name		N/A	N/A	Road X Slope (%)	N/A	N/A	Clear Space to XWalk (in)	N/A
Stop Condition-Street 1		N/A	N/A	Any Obstructions?	N/A	N/A	Storm Grate/Utility Hazard?	N/A
Total Cost:		\$ 1850.00		Obstruction Type			Storm Grate/Utility Type	
					N/A			N/A
						Yes	Surface Condition? (G/P)	Good
