Access Compliance Report

Public Rights-of-Way

(Curb Ramps)

| Intersection ID: 48198 | Main Street: RIVERGATE PY | Cross Street: S TRYON ST | Location: NW |

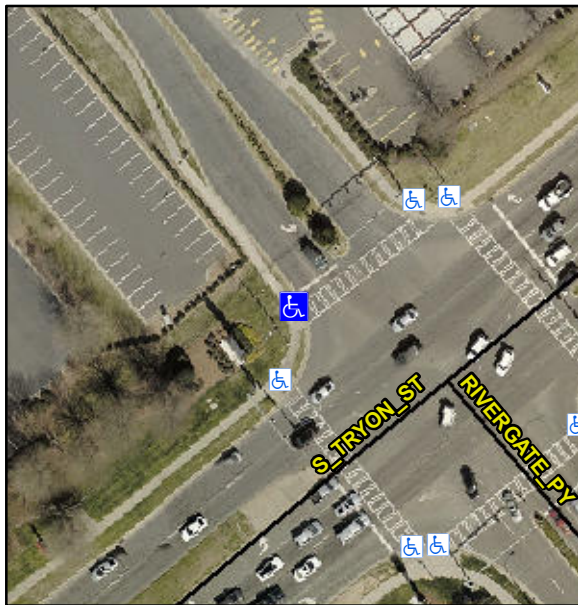
| ADA ID: 5461C9355A5B | Ramp Type: Perp | Initial Pass/Fail: Fail | Overall Compliance: No |
| | | Severity Score: 8.75 | |

Not Found, R304.5.1

| Compliance | Description | Data | Compliance | Description | Data |
|---|---|---|---|---|---|
| N/A | Ramp Length (in) | 96.0 | Yes | Ramp Slope (%) | 7.7 |
| No | Ramp Width (in) | 47.0 | Yes | Ramp XSlope (%) | 1.4 |

Remove & Replace Entire Ramp.

Total Cost: \$ 1850.00
