# Access Compliance Report

## Public Rights-of-Way

Intersection ID: 29952	Main Street: CANIPE_DR	Cross Street: DAVIS_RIDGE_DR	Location: N
ADA ID: 54840D0BFFFF	Ramp Type: PerpDiag	Initial Pass/Fail: Fail	Overall Compliance: No
Severity Score: 33.75			
Codes/Mitigation Info/Possible Solution		Field Measurements/Component Compliance

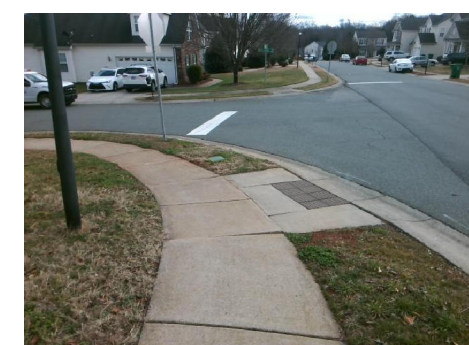
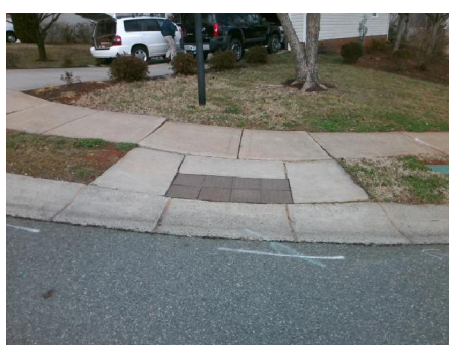
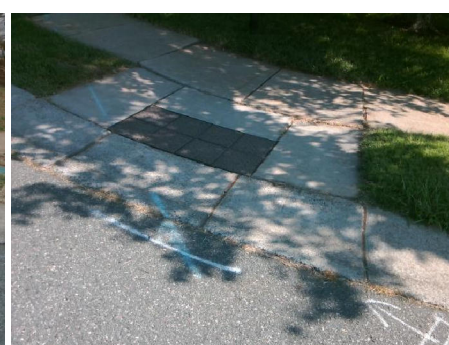
**Not Found, R304.5.1, R304.5.3**

Compliance	Description	Data	Compliance	Description	Data
N/A	Ramp Length (in)	46.5	Yes	Ramp Slope (%)	7.5
No	Ramp Width (in)	44.0	No	Ramp XSlope (%)	9.1
N/A	Flare Type LT	N/A	N/A	Flare Type RT	N/A
N/A	Flare Slope LT (%)	N/A	N/A	Flare Slope RT (%)	N/A
N/A	Flare Traversable LT?	N/A	N/A	Flare Traversable RT?	N/A
N/A	Landing Length (in)	N/A	N/A	DWS Provided?	N/A
N/A	Landing Width (in)	N/A	N/A	DWS Contrast?	N/A
N/A	Landing Slope (%)	N/A	N/A	DWS Length (in)	N/A
N/A	Landing X Slope (%)	N/A	N/A	DWS Full Width?	N/A
N/A	Landing Curb? (Y/N)	N/A	N/A	DWS Offset (in)	N/A
N/A	Shared Landing?	N/A			
N/A	Gutter Ponding?	N/A	N/A	Gutter Slope (%)	N/A
N/A	Gutter Lip Ht (in)	N/A	N/A	Gutter X Slope (%)	N/A
N/A	Painted X Walk1?	No	N/A	Painted X Walk2?	No
	X Walk 1 Direction	To SE		X Walk 2 Direction	To SW
N/A	X Walk 1 Width (in)	N/A	N/A	X Walk 2 Width (in)	N/A
	X Walk 1 Slope (%)	5.0		X Walk 2 Slope (%)	5.5
	X Walk 1 X Slope (%)	7.6		X Walk 2 X Slope (%)	8.3

N/A	Ramp inside XWalk1?	N/A	N/A	Ramp inside XWalk2?	N/A
	Road Slope (%)	9.4	N/A	Clear Space?	N/A
	Road X Slope (%)	2.2	N/A	Clear Space to XWalk (in)	N/A
N/A	Any Obstructions?	N/A	N/A	Storm Grate/Utility Hazard?	N/A
	Obstruction Type			Storm Grate/Utility Type	
		N/A			N/A
			Yes	Surface Condition? (G/P)	Good

**Remove & Replace Curb Ramp With Two New Directional Ramps or Equivalent.**
