## **Access Compliance Report Public Rights-of-Way** (Curb Ramps)

**Cross Street: TAMORA DR** Location: Intersection ID: 14184 Main Street: FAULCONBRIDGE RD W Initial Pass/Fail: Fail **Overall Compliance: No** ADA ID: 548E9C429AF0 Ramp Type: Directional1 **Severity Score:** 8.75

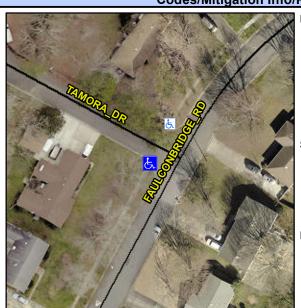
N/A	Ramp Length (in)
No	Ramp Width (in)
Yes	Ramp Slope (%)
Yes	Ramp XSlope (%)
N/A	Flare Type LT
N/A	Flare Slope LT (%)
N/A	Flare Traversable LT?
N/A	Landing Length (in)
N/A	Landing Width (in)
N/A	Landing Slope (%)
N/A	Landing X Slope (%)
N/A	Landing Curb? (Y/N)
N/A	Shared Landing?
N/A	Gutter Ponding?
N/A	Gutter Lip Ht (in)
N/A	Painted X Walk1?
	X Walk 1 Direction
	X Walk 1 Width (in)
	X Walk 1 Slope (%)
	X Walk 1 X Slope (%)
N/A	Ramp inside XWalk1?
N/A	Any Obstructions?

TAMORA DR Street 1 Name Stop Condition-Street 1 StopSign N/A Street 2 Name Stop Condition-Street 2 N/A Possible Solutions: Remove & Replace Entire Ramp. Surveyor Notes: N/A PROW/ADA: R304.5.1
