Access Compliance Report

Public Rights-of-Way

(Curb Ramps)

Intersection ID: 27620	Main Street: CAMFIELD_ST	Cross Street: ELM_LN	Location: NW
ADA ID: 54A0F3104BF4	Ramp Type: PerpDiag	Initial Pass/Fail: Fail	Overall Compliance: No
		Severity Score: 22.5

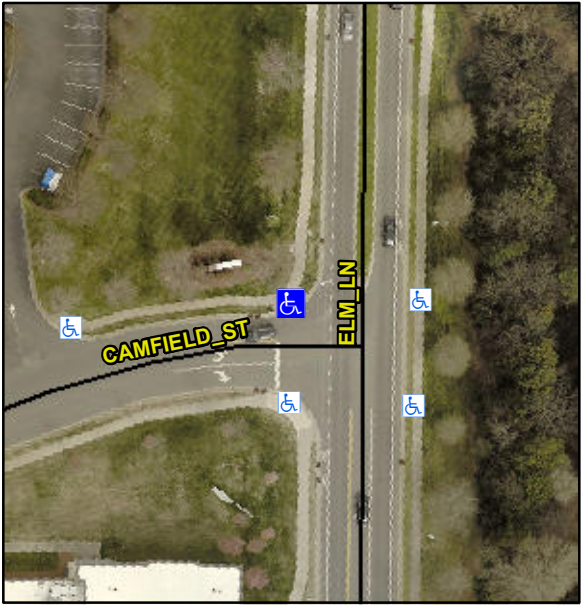
Possible Solutions:		Compliance	Description	Data
	Remove & Replace Curb Ramp With Two New Directional Ramps or Equivalent.		No	Ramp Length (in)	47.0
			No	Ramp Width (in)	47.5
			N/A	Flare Type LT	N/A
			N/A	Flare Slope LT (%)	N/A
			N/A	Flare Traversable LT?	N/A
			N/A	Landing Length (in)	N/A
			N/A	Landing Width (in)	N/A
			N/A	Landing Slope (%)	N/A
			N/A	Landing X Slope (%)	N/A
			N/A	Landing Curb? (Y/N)	N/A
			N/A	Shared Landing?	N/A
			N/A	Gutter Ponding?	N/A
			N/A	Gutter Lip Ht (in)	N/A
			No	Painted X Walk1?	N/A
				X Walk 1 Direction	To S
			N/A	X Walk 1 Width (in)	N/A
				X Walk 1 Slope (%)	1.3
				X Walk 1 X Slope (%)	0.6
			N/A	Ramp inside XWalk1?	N/A
<p>Surveyor Notes:</p> <p>N/A</p> <p>PROW/ADA:</p> <p>Not Found, R304.5.1, R304.2.2, R304.5.3</p>			N/A	Flare Type RT	N/A
			N/A	Flare Slope RT (%)	N/A
			N/A	Flare Traversable RT?	N/A
