Access Compliance Report

Public Rights-of-Way

(Curb Ramps)

Intersection ID: 31884	Main Street: CENTERLINE_DR	Cross Street: LIFELINE_LN	Location: SW
ADA ID: 54A21E9EA9B9	Ramp Type: PerpDiag	Initial Pass/Fail: Fail	Overall Compliance: No
Severity Score: 22.5			
Codes/Mitigation Info/Possible Solution		Field Measurements/Component Compliance

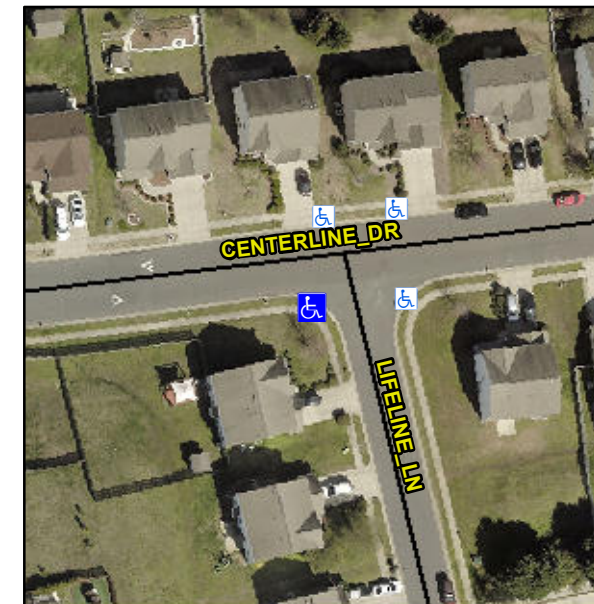
Not Found, R304.5.1, R304.2.2, R304.5.3

Compliance	Description	Data	Compliance	Description	Data
N/A	Ramp Length (in)	46.0	No	Ramp Slope (%)	8.6
No	Ramp Width (in)	47.5	No	Ramp XSlope (%)	2.8
N/A	Flare Type LT	N/A	N/A	Flare Type RT	N/A
N/A	Flare Slope LT (%)	N/A	N/A	Flare Slope RT (%)	N/A
N/A	Flare Traversable LT?	N/A	N/A	Flare Traversable RT?	N/A
N/A	Landing Length (in)	N/A	N/A	DWS Provided?	N/A
N/A	Landing Width (in)	N/A	N/A	DWS Contrast?	N/A
N/A	Landing Slope (%)	N/A	N/A	DWS Length (in)	N/A
N/A	Landing X Slope (%)	N/A	N/A	DWS Full Width?	N/A
N/A	Landing Curb? (Y/N)	N/A	N/A	DWS Offset (in)	N/A
N/A	Shared Landing?	N/A			
N/A	Gutter Ponding?	N/A	N/A	Gutter Slope (%)	N/A
N/A	Gutter Lip Ht (in)	N/A	N/A	Gutter X Slope (%)	N/A
N/A	Painted X Walk1?	No	N/A	Painted X Walk2?	No
	X Walk 1 Direction	To E		X Walk 2 Direction	To N
N/A	X Walk 1 Width (in)	N/A	N/A	X Walk 2 Width (in)	N/A
	X Walk 1 Slope (%)	3.1		X Walk 2 Slope (%)	2.5
	X Walk 1 X Slope (%)	1.2		X Walk 2 X Slope (%)	1.7

N/A	Ramp inside XWalk1?	N/A	N/A	Ramp inside XWalk2?	N/A
	Road Slope (%)	1.2	N/A	Clear Space?	N/A
	Road X Slope (%)	2.7	N/A	Clear Space to XWalk (in)	N/A
N/A	Any Obstructions?	N/A	N/A	Storm Grate/Utility Hazard?	N/A
	Obstruction Type			Storm Grate/Utility Type	
		N/A			N/A
			Yes	Surface Condition? (G/P)	Good

Remove & Replace Curb Ramp With Two New Directional Ramps or Equivalent.
