Access Compliance Report Public Rights-of-Way (Curb Ramps)

Intersection ID: 9762 Main Street: CAMBRIDGE_COMMONS_DR Cross Street: WOODHILL_MANOR_CT Location: Ε

ADA ID: 54B26E234D77 Ramp Type: Directional1 Initial Pass/Fail: Fail **Overall Compliance: No Severity Score:** 10

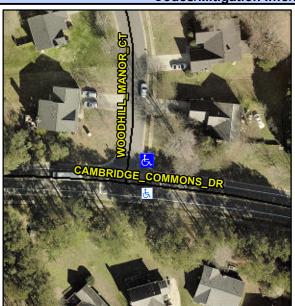
/Possible Solution			Field Measurements/Component Compliance				
Possible Solutions:			Comp	Data	Compliance Description		
Remove & Replace Entire	Ram	ıp.	N/A	Ramp Length (in)	35.0	N/A	Grade Break?
·		•	No	Ramp Width (in)	44.0	N/A	Grade Break Slope (%)
			Yes	Ramp Slope (%)	5.8	N/A	Grade Break XSlope (%)
			No	Ramp XSlope (%)	4.2		
			N/A	Flare Type LT	N/A	N/A	Flare Type RT
			N/A	Flare Slope LT (%)	N/A	N/A	Flare Slope RT (%)
Surveyor Notes:			N/A	Flare Traversable LT?	N/A	N/A	Flare Traversable RT?
CURB GAP 1.0"			N/A	Landing Length (in)	0.0	N/A	DWS Provided?
			N/A	Landing Width (in)	0.0	N/A	DWS Contrast?
			N/A	Landing Slope (%)	0.0	N/A	DWS Length (in)
			N/A	Landing X Slope (%)	0.0	N/A	DWS Full Width?
PROW/ADA:			N/A	Landing Curb? (Y/N)	N/A	N/A	DWS Offset LT (in)
R304.5.1, R304.5.3			N/A	Shared Landing?	N/A	N/A	DWS Offset RT (in)
			N/A	Gutter Ponding?	0.0	N/A	Gutter Slope (%)
			N/A	Gutter Lip Ht (in)	0.0	N/A	Gutter X Slope (%)

N/A	Painted X Walk1?	No		Road Slope (%)
				X Walk 1 Direction	To W		Road X Slope (%)
				X Walk 1 Width (in)	N/A		Clear Space?
				X Walk 1 Slope (%)	5.4	N/A	Clear Space to XWalk (in)
				X Walk 1 X Slope (%)	0.6	N/A	Storm Grate/Utility Hazard?
			N/A	Ramp inside XWalk1?	N/A		Storm Grate/Utility Type
			N/A	Any Obstructions?	N/A		
Total Cost:	\$	1600.00		Obstruction Type		Yes	Surface Condition? (G/P)
