Access Compliance Report Public Rights-of-Way (Curb Ramps)

Intersection ID: 6579 Main Street: MINERAL SPRINGS RD **Cross Street: CENTURY OAKS LN** Location: Ε **Overall Compliance: No Severity Score:**

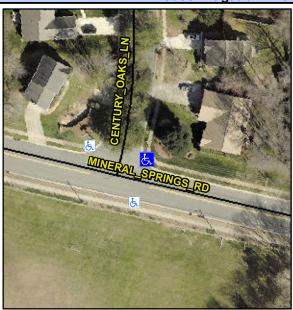
Initial Pass/Fail: Fail

Ramp Type: PerpDiag

Not Found, R304.5.1

CENTURY OAKS LN Street 1 Name StopSign **MINERAL SPRINGS RD** None Compliance Description Data Compliance Description Data Yes Ramp Slope (%) N/A Ramp Length (in) 48.0 6.3 Yes Ramp XSlope (%) No Ramp Width (in) 43.0 0.9 N/A N/A Flare Type LT N/A Flare Type RT N/A N/A N/A N/A Flare Slope RT (%) N/A Flare Slope LT (%) N/A Flare Traversable LT? N/A N/A Flare Traversable RT? N/A N/A N/A N/A **DWS Provided?** N/A Landing Length (in) N/A Landing Width (in) N/A N/A **DWS Contrast?** N/A N/A N/A Landing Slope (%) N/A DWS Length (in) N/A N/A Landing X Slope (%) N/A N/A DWS Full Width? N/A N/A Landing Curb? (Y/N) N/A N/A DWS Offset (in) N/A N/A N/A Shared Landing? N/A **Gutter Ponding?** N/A N/A Gutter Slope (%) N/A N/A Gutter Lip Ht (in) N/A N/A Gutter X Slope (%) N/A N/A Painted X Walk1? No N/A Painted X Walk2? No X Walk 1 Direction To NW X Walk 2 Direction To S N/A N/A X Walk 1 Width (in) X Walk 2 Width (in) N/A X Walk 1 Slope (%) X Walk 2 Slope (%) 1.8 1.2 X Walk 1 X Slope (%) 0.3 X Walk 2 X Slope (%) 0.5 N/A N/A N/A Ramp inside XWalk2? N/A Ramp inside XWalk1? Road Slope (%) 0.9 N/A Clear Space? N/A N/A Road X Slope (%) Clear Space to XWalk (in) N/A 0.9 N/A N/A N/A Any Obstructions? Storm Grate/Utility Hazard? N/A **Obstruction Type** Storm Grate/Utility Type N/A N/A

Remove & Replace Curb Ramp With Two New Directional Ramps or Equivalent.
