Access Compliance Report

Public Rights-of-Way

(Curb Ramps)

| Intersection ID: 8329 | Main Street: BEATTIES_FORD_RD | Cross Street: LASALLE_ST | Location: SE |

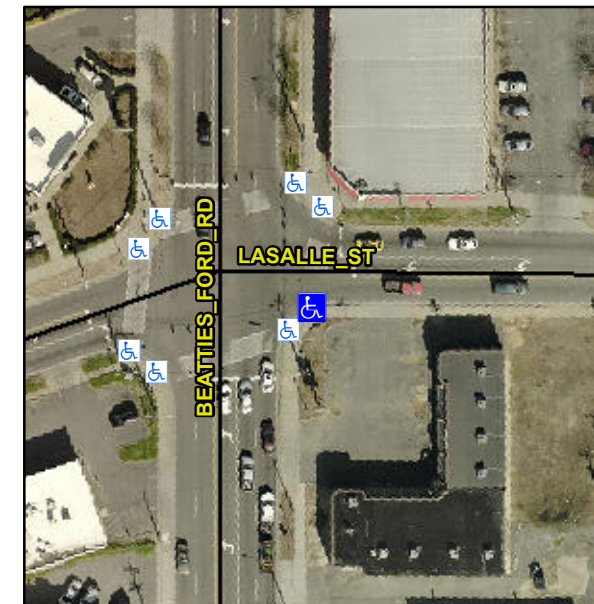
| ADA ID: 54B7428B23B0 | Ramp Type: Perp | Initial Pass/Fail: Fail | Overall Compliance: No |

Not Found, R304.5.1, R304.5.3

| Compliance | Description | Data | Compliance | Description | Data |
|---|---|---|---|---|---|
| N/A | Ramp Length (in) | 78.0 | Yes | Ramp Slope (%) | 6.6 |
| No | Ramp Width (in) | 46.0 | No | Ramp XSlope (%) | 2.3 |

Remove & Replace Entire Ramp.
