Access Compliance Report

Public Rights-of-Way

(Curb Ramps)

| Intersection ID: 50635 | Main Street: RED_WATER_RD | Cross Street: BLUE_BLOSSOM_RD | Location: W |

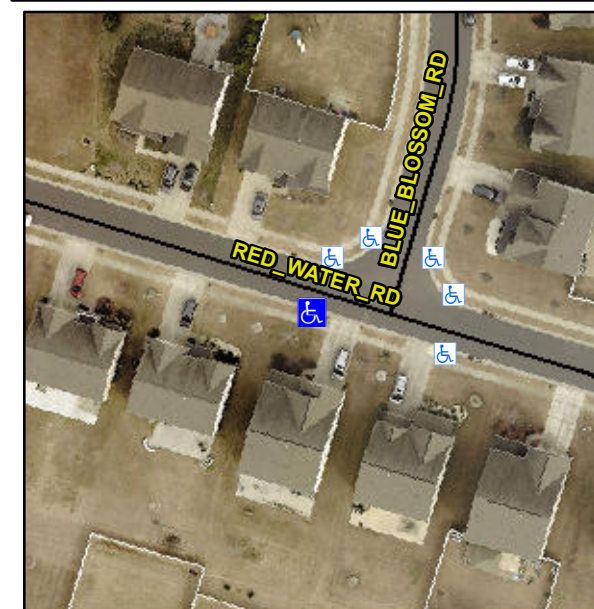
Not Found, R304.2.2

| Compliance | Description | Data | Compliance | Description | Data |
|---|---|---|---|---|---|
| N/A | Ramp Length (in) | 48.0 | No | Ramp Slope (%) | 9.1 |

Remove & Replace Entire Ramp.

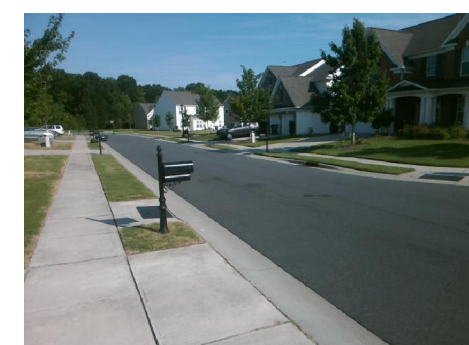
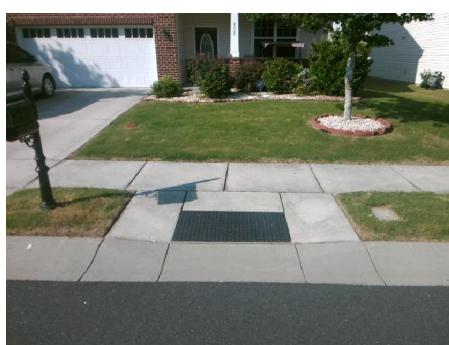
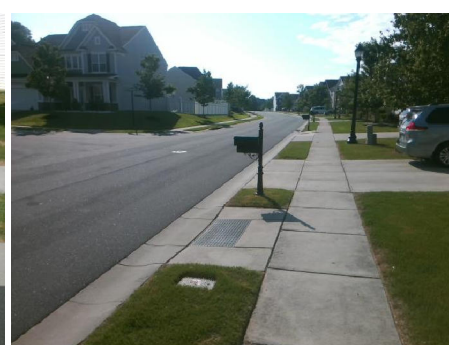
| Compliance | Description | Data | Compliance | Description | Data |
|---|---|---|---|---|---|
| Yes | Ramp Width (in) | 48.0 | Yes | Ramp XSlope (%) | 1.3 |
