| Intersection ID: 16828 | Main Street: BUCKNELL_AV | Cross Street: SELWYN_AV | Location: | NW |
| ADA ID: 54BDCE005A8B | Ramp Type: Perp | Initial Pass/Fail: Fail | Overall Compliance: No | Severity Score: 33.75 |

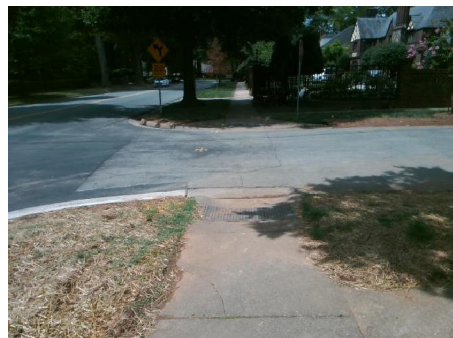
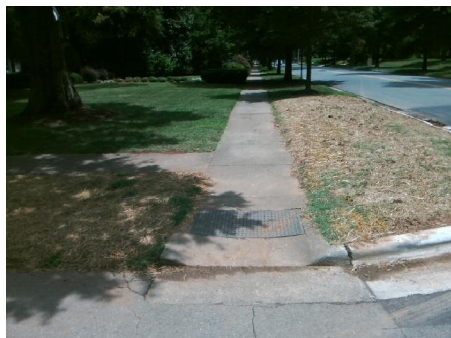
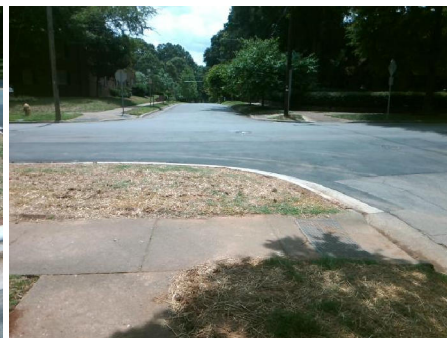
| Compliance | Description | Data | Compliance | Description | Data |
|---|---|---|---|---|---|
| N/A | Ramp Length (in) | 59.0 | No | Ramp Slope (%) | 9.9 |
| No | Ramp Width (in) | 42.0 | No | Ramp XSlope (%) | 5.4 |

### Remove & Replace Entire Ramp.

**R304.5.1, R304.2.2, R304.5.3**

Total Cost: \$ 1850.00
