# Access Compliance Report

## Public Rights-of-Way

### (Curb Ramps)

Intersection ID: 13159	Main Street: CENTRAL_AV	Cross Street: NANDINA_ST	Location: SE
ADA ID: 54C830C2D041	Ramp Type: PerpDiag	Initial Pass/Fail: Fail	Overall Compliance: No
		Severity Score: 10

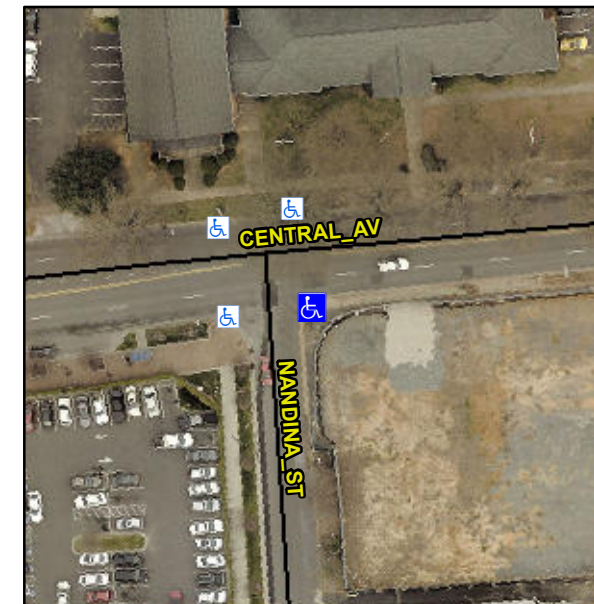
**Not Found, R304.5.1, R304.5.3**

Compliance	Description	Data	Compliance	Description	Data
N/A	Ramp Length (in)	53.5	Yes	Ramp Slope (%)	7.0
No	Ramp Width (in)	40.4	No	Ramp XSlope (%)	3.2
N/A	Flare Type LT	N/A	N/A	Flare Type RT	N/A
N/A	Flare Slope LT (%)	N/A	N/A	Flare Slope RT (%)	N/A
N/A	Flare Traversable LT?	N/A	N/A	Flare Traversable RT?	N/A
N/A	Landing Length (in)	N/A	N/A	DWS Provided?	N/A
N/A	Landing Width (in)	N/A	N/A	DWS Contrast?	N/A
N/A	Landing Slope (%)	N/A	N/A	DWS Length (in)	N/A
N/A	Landing X Slope (%)	N/A	N/A	DWS Full Width?	N/A
N/A	Landing Curb? (Y/N)	N/A	N/A	DWS Offset (in)	N/A
N/A	Shared Landing?	N/A			
N/A	Gutter Ponding?	N/A	N/A	Gutter Slope (%)	N/A
N/A	Gutter Lip Ht (in)	N/A	N/A	Gutter X Slope (%)	N/A
N/A	Painted X Walk1?	No	N/A	Painted X Walk2?	No
	X Walk 1 Direction	To N		X Walk 2 Direction	To W
N/A	X Walk 1 Width (in)	N/A	N/A	X Walk 2 Width (in)	N/A
	X Walk 1 Slope (%)	3.4		X Walk 2 Slope (%)	3.2
	X Walk 1 X Slope (%)	3.7		X Walk 2 X Slope (%)	1.9

N/A	Ramp inside XWalk1?	N/A	N/A	Ramp inside XWalk2?	N/A
	Road Slope (%)	2.1	N/A	Clear Space?	N/A
	Road X Slope (%)	3.3	N/A	Clear Space to XWalk (in)	N/A
N/A	Any Obstructions?	N/A	N/A	Storm Grate/Utility Hazard?	N/A
	Obstruction Type			Storm Grate/Utility Type	
		N/A			N/A
			Yes	Surface Condition? (G/P)	Good

**Remove & Replace Curb Ramp With Two New Directional Ramps or Equivalent.**
