Access Compliance Report Public Rights-of-Way (Curb Ramps)

Intersection ID: 10023486 Main Street: CIRCUMFERENTIAL_RD Cross Street: N/A Location: NE

ADA ID: 54C9CFD2FFD7 Ramp Type: Directional1 Initial Pass/Fail: Fail Overall Compliance: No Severity Score: 1.25

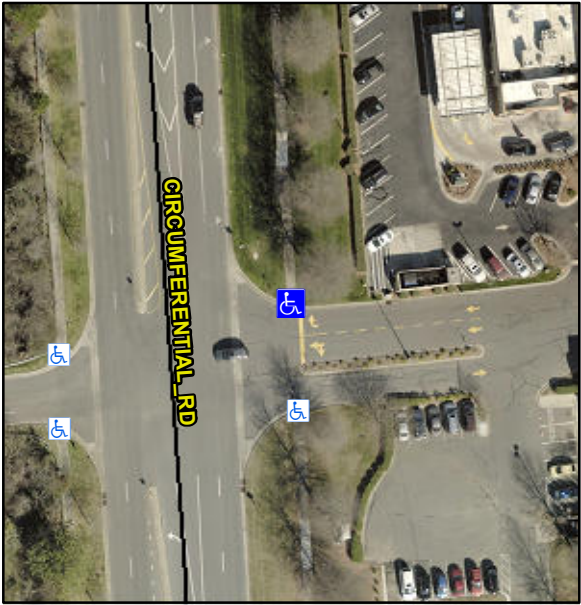
Compliance	Description	Data	Compliance	Description	Data
N/A	Ramp Length (in)	61.0	N/A	Grade Break?	N/A
Yes	Ramp Width (in)	58.0	N/A	Grade Break Slope (%)	0.0
Yes	Ramp Slope (%)	1.2	N/A	Grade Break XSlope (%)	0.0
No	Ramp XSlope (%)	3.3			
N/A	Flare Type LT	N/A	N/A	Flare Type RT	N/A
N/A	Flare Slope LT (%)	N/A	N/A	Flare Slope RT (%)	0.0
N/A	Flare Traversable LT?	N/A	N/A	Flare Traversable RT?	N/A
N/A	Landing Length (in)	0.0	N/A	DWS Provided?	N/A
N/A	Landing Width (in)	0.0	N/A	DWS Contrast?	N/A
N/A	Landing Slope (%)	0.0	N/A	DWS Length (in)	N/A
N/A	Landing X Slope (%)	0.0	N/A	DWS Full Width?	N/A
N/A	Landing Curb? (Y/N)	N/A	N/A	DWS Offset LT (in)	N/A
N/A	Shared Landing?	N/A	N/A	DWS Offset RT (in)	N/A
N/A	Gutter Ponding?	0.0	N/A	Gutter Slope (%)	N/A
N/A	Gutter Lip Ht (in)	0.0	N/A	Gutter X Slope (%)	N/A
N/A	Painted X Walk1?	No		Road Slope (%)	1.6
	X Walk 1 Direction	To S		Road X Slope (%)	4.2
	X Walk 1 Width (in)	N/A		Clear Space?	N/A

X Walk 1 Slope (%)	1.6	N/A	Clear Space to XWalk (in)	N/A
	X Walk 1 X Slope (%)	4.2	N/A	Storm Grate/Utility Hazard?	N/A
N/A	Ramp inside XWalk1?	N/A		Storm Grate/Utility Type	
N/A	Any Obstructions?	N/A			N/A
	Obstruction Type		Yes	Surface Condition? (G/P)	Good
			N/A	Curb Slope (%)	3.7

Possible Solutions:
Remove & Replace Entire Ramp.

PROW/ADA:
R304.5.3
