# Access Compliance Report

## Public Rights-of-Way

Intersection ID: 18641	Main Street: PORTBURN_RD	Cross Street: RAMA_RD	Location:	N
ADA ID: 54DE2B388439	Ramp Type: PerpDiag	Initial Pass/Fail: Fail	Overall Compliance: No	Severity Score: 25

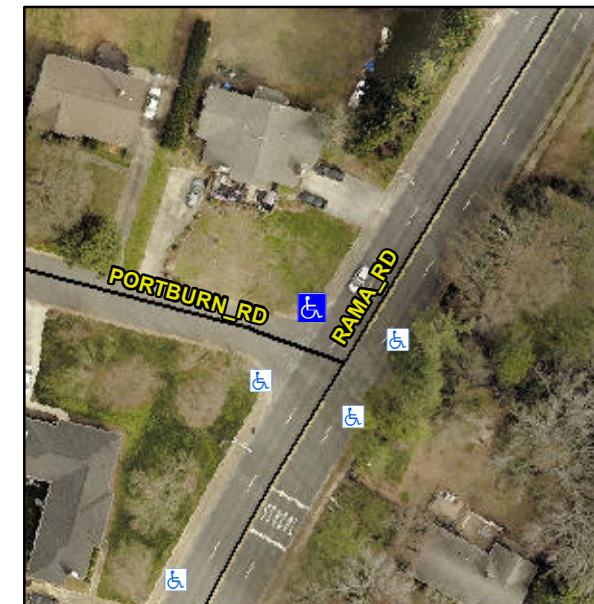
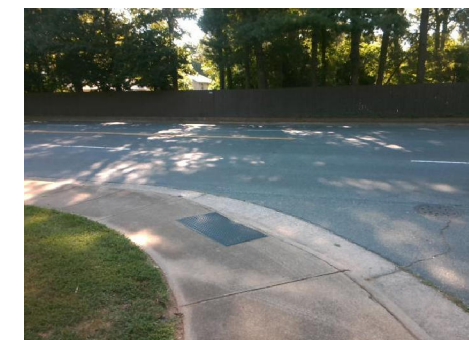
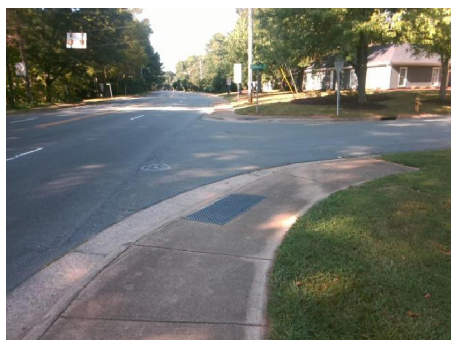
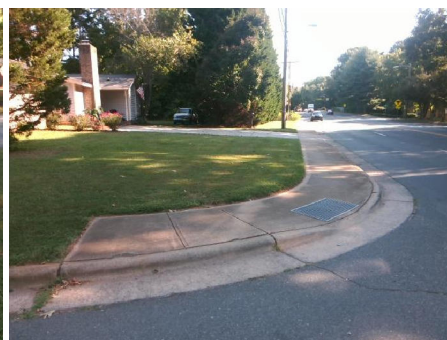
**Not Found, R304.5.3**

Compliance	Description	Data	Compliance	Description	Data
N/A	Ramp Length (in)	58.0	Yes	Ramp Slope (%)	7.8
Yes	Ramp Width (in)	48.0	No	Ramp XSlope (%)	7.9
N/A	Flare Type LT	N/A	N/A	Flare Type RT	N/A
N/A	Flare Slope LT (%)	N/A	N/A	Flare Slope RT (%)	N/A
N/A	Flare Traversable LT?	N/A	N/A	Flare Traversable RT?	N/A
N/A	Landing Length (in)	N/A	N/A	DWS Provided?	N/A
N/A	Landing Width (in)	N/A	N/A	DWS Contrast?	N/A
N/A	Landing Slope (%)	N/A	N/A	DWS Length (in)	N/A
N/A	Landing X Slope (%)	N/A	N/A	DWS Full Width?	N/A
N/A	Landing Curb? (Y/N)	N/A	N/A	DWS Offset (in)	N/A
N/A	Shared Landing?	N/A			
N/A	Gutter Ponding?	N/A	N/A	Gutter Slope (%)	N/A
N/A	Gutter Lip Ht (in)	N/A	N/A	Gutter X Slope (%)	N/A
N/A	Painted X Walk1?	No	N/A	Painted X Walk2?	No
	X Walk 1 Direction	To SW		X Walk 2 Direction	To SE
N/A	X Walk 1 Width (in)	N/A	N/A	X Walk 2 Width (in)	N/A
	X Walk 1 Slope (%)	2.7		X Walk 2 Slope (%)	1.4
	X Walk 1 X Slope (%)	2.0		X Walk 2 X Slope (%)	2.3

N/A	Ramp inside XWalk1?	N/A	N/A	Ramp inside XWalk2?	N/A
	Road Slope (%)	1.6	N/A	Clear Space?	N/A
	Road X Slope (%)	1.3	N/A	Clear Space to XWalk (in)	N/A
N/A	Any Obstructions?	N/A	N/A	Storm Grate/Utility Hazard?	N/A
	Obstruction Type			Storm Grate/Utility Type	
		N/A			N/A
			Yes	Surface Condition? (G/P)	Good

**Remove & Replace Curb Ramp With Two New Directional Ramps or Equivalent.**
