# Access Compliance Report

## Public Rights-of-Way

### (Curb Ramps)

Intersection ID: 53270	Main Street: MONROE_RD	Cross Street: MERIDIAN_CENTER_DR	Location: NE
ADA ID: 54E282298A8A	Ramp Type: Directional1	Initial Pass/Fail: Fail	Overall Compliance: No
		Severity Score: 1.25

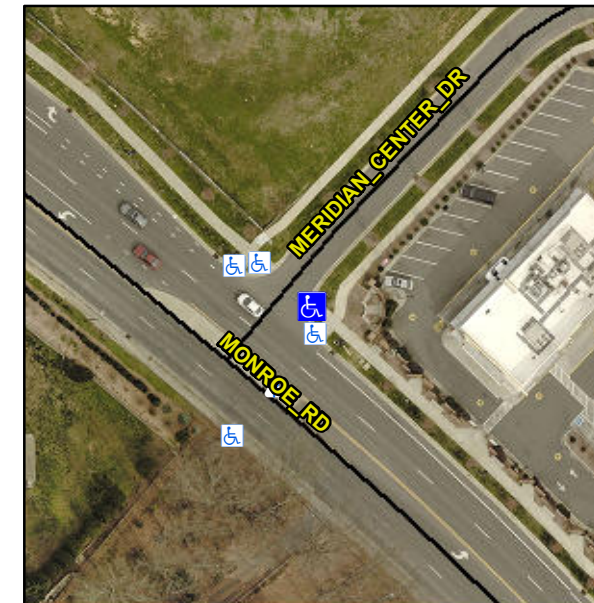
Compliance	Description	Data	Compliance	Description	Data
N/A	Ramp Length (in)	95.0	N/A	Grade Break?	N/A
Yes	Ramp Width (in)	72.0	N/A	Grade Break Slope (%)	0.0
Yes	Ramp Slope (%)	6.3	N/A	Grade Break XSlope (%)	0.0
No	Ramp XSlope (%)	2.3			
N/A	Flare Type LT	N/A	N/A	Flare Type RT	N/A
N/A	Flare Slope LT (%)	N/A	N/A	Flare Slope RT (%)	0.0
N/A	Flare Traversable LT?	N/A	N/A	Flare Traversable RT?	N/A
N/A	Landing Length (in)	0.0	N/A	DWS Provided?	N/A
N/A	Landing Width (in)	0.0	N/A	DWS Contrast?	N/A
N/A	Landing Slope (%)	0.0	N/A	DWS Length (in)	N/A
N/A	Landing X Slope (%)	0.0	N/A	DWS Full Width?	N/A
N/A	Landing Curb? (Y/N)	N/A	N/A	DWS Offset LT (in)	N/A
N/A	Shared Landing?	N/A	N/A	DWS Offset RT (in)	N/A
N/A	Gutter Ponding?	0.0	N/A	Gutter Slope (%)	N/A
N/A	Gutter Lip Ht (in)	0.0	N/A	Gutter X Slope (%)	N/A
N/A	Painted X Walk1?	No		Road Slope (%)	1.0
	X Walk 1 Direction	To NW		Road X Slope (%)	1.1
	X Walk 1 Width (in)	N/A		Clear Space?	N/A

X Walk 1 Slope (%)	1.0	N/A	Clear Space to XWalk (in)	N/A
	X Walk 1 X Slope (%)	1.1	N/A	Storm Grate/Utility Hazard?	N/A
N/A	Ramp inside XWalk1?	N/A		Storm Grate/Utility Type	
N/A	Any Obstructions?	N/A			N/A
	Obstruction Type		Yes	Surface Condition? (G/P)	Good
			N/A	Curb Slope (%)	6.4

Possible Solutions:

**Remove & Replace Entire Ramp.**

PROW/ADA:

**R304.5.3**
