Intersection ID: 23232	Main Street: PARK_RD	Cross Street: QUAIL_HILL_RD	Location:	SW
ADA ID: 54E7C7985C17	Ramp Type: PerpDiag	Initial Pass/Fail: Fail	Overall Compliance: No	Severity Score: 13.75

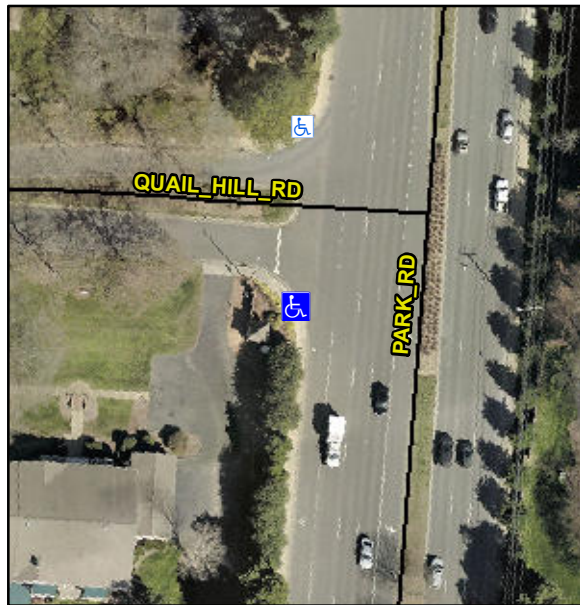
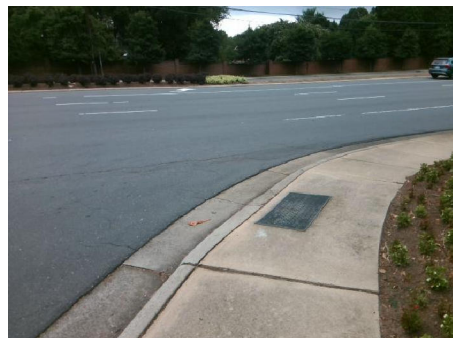
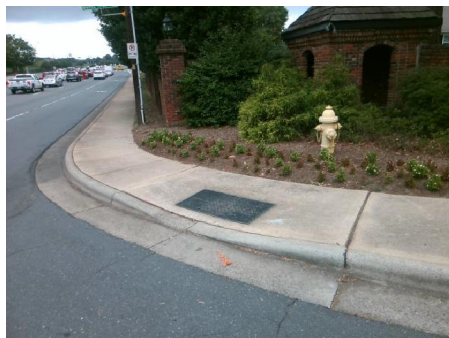
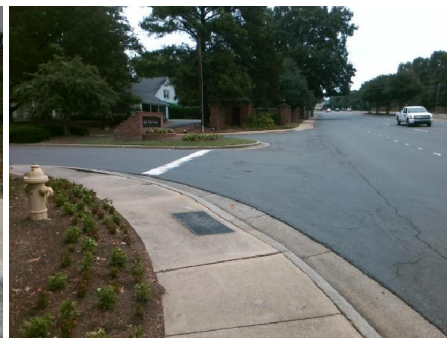
R304.2.2, R304.5.3

Compliance	Description	Data	Compliance	Description	Data
N/A	Ramp Length (in)	59.0	No	Ramp Slope (%)	8.4
Yes	Ramp Width (in)	48.0	No	Ramp XSlope (%)	2.7
N/A	Flare Type LT	N/A	N/A	Flare Type RT	N/A
N/A	Flare Slope LT (%)	N/A	N/A	Flare Slope RT (%)	N/A
N/A	Flare Traversable LT?	N/A	N/A	Flare Traversable RT?	N/A
N/A	Landing Length (in)	N/A	N/A	DWS Provided?	N/A
N/A	Landing Width (in)	N/A	N/A	DWS Contrast?	N/A
N/A	Landing Slope (%)	N/A	N/A	DWS Length (in)	N/A
N/A	Landing X Slope (%)	N/A	N/A	DWS Full Width?	N/A
N/A	Landing Curb? (Y/N)	N/A	N/A	DWS Offset (in)	N/A
N/A	Shared Landing?	N/A			
N/A	Gutter Ponding?	N/A	N/A	Gutter Slope (%)	N/A
N/A	Gutter Lip Ht (in)	N/A	N/A	Gutter X Slope (%)	N/A
N/A	Painted X Walk1?	No	N/A	Painted X Walk2?	No
	X Walk 1 Direction	To SE		X Walk 2 Direction	To NE
N/A	X Walk 1 Width (in)	N/A	N/A	X Walk 2 Width (in)	N/A
	X Walk 1 Slope (%)	5.5		X Walk 2 Slope (%)	2.4
	X Walk 1 X Slope (%)	3.7		X Walk 2 X Slope (%)	2.3

N/A	Ramp inside XWalk1?	N/A	N/A	Ramp inside XWalk2?	N/A
	Road Slope (%)	2.7	N/A	Clear Space?	N/A
	Road X Slope (%)	0.8	N/A	Clear Space to XWalk (in)	N/A
N/A	Any Obstructions?	N/A	N/A	Storm Grate/Utility Hazard?	N/A
	Obstruction Type			Storm Grate/Utility Type	
		N/A			N/A
			Yes	Surface Condition? (G/P)	Good

Remove & Replace Curb Ramp With Two New Directional Ramps or Equivalent.
