Access Compliance Report

Public Rights-of-Way

(Curb Ramps)

Intersection ID: 17473	Main Street: CHELTENHAM_RD	Cross Street: HEATHWOOD_RD	Location: S
ADA ID: 54FC08FAC2F9	Ramp Type: PerpDiag	Initial Pass/Fail: Fail	Overall Compliance: No
		Severity Score: 22.5

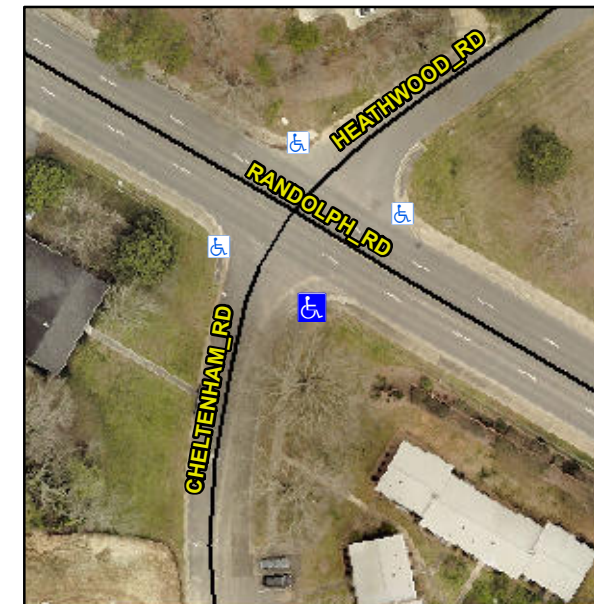
Not Found, R304.5.1, R304.2.2, R304.5.3

Compliance	Description	Data	Compliance	Description	Data
N/A	Ramp Length (in)	48.0	No	Ramp Slope (%)	9.6
No	Ramp Width (in)	36.0	No	Ramp XSlope (%)	2.1
N/A	Flare Type LT	N/A	N/A	Flare Type RT	N/A
N/A	Flare Slope LT (%)	N/A	N/A	Flare Slope RT (%)	N/A
N/A	Flare Traversable LT?	N/A	N/A	Flare Traversable RT?	N/A
N/A	Landing Length (in)	N/A	N/A	DWS Provided?	N/A
N/A	Landing Width (in)	N/A	N/A	DWS Contrast?	N/A
N/A	Landing Slope (%)	N/A	N/A	DWS Length (in)	N/A
N/A	Landing X Slope (%)	N/A	N/A	DWS Full Width?	N/A
N/A	Landing Curb? (Y/N)	N/A	N/A	DWS Offset (in)	N/A
N/A	Shared Landing?	N/A			
N/A	Gutter Ponding?	N/A	N/A	Gutter Slope (%)	N/A
N/A	Gutter Lip Ht (in)	N/A	N/A	Gutter X Slope (%)	N/A
N/A	Painted X Walk1?	No	N/A	Painted X Walk2?	No
	X Walk 1 Direction	To NE		X Walk 2 Direction	To NW
N/A	X Walk 1 Width (in)	N/A	N/A	X Walk 2 Width (in)	N/A
	X Walk 1 Slope (%)	5.7		X Walk 2 Slope (%)	3.8
	X Walk 1 X Slope (%)	3.4		X Walk 2 X Slope (%)	3.0

N/A	Ramp inside XWalk1?	N/A	N/A	Ramp inside XWalk2?	N/A
	Road Slope (%)	1.5	N/A	Clear Space?	N/A
	Road X Slope (%)	5.5	N/A	Clear Space to XWalk (in)	N/A
N/A	Any Obstructions?	N/A	N/A	Storm Grate/Utility Hazard?	N/A
	Obstruction Type			Storm Grate/Utility Type	
		N/A			N/A
			Yes	Surface Condition? (G/P)	Good

Remove & Replace Curb Ramp With Two New Directional Ramps or Equivalent.
