Access Compliance Report

Public Rights-of-Way

(Curb Ramps)

| Intersection ID: 29988 | Main Street: REIGATE_RD | Cross Street: BARVAS_ST | Location: E |

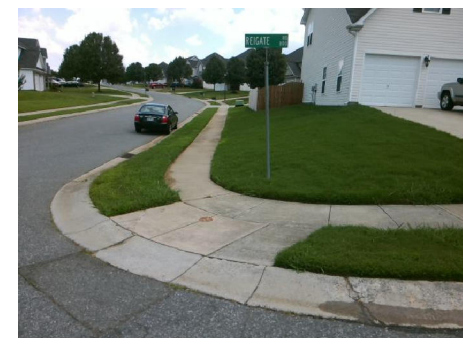
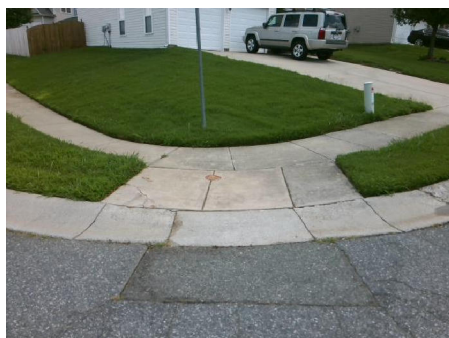
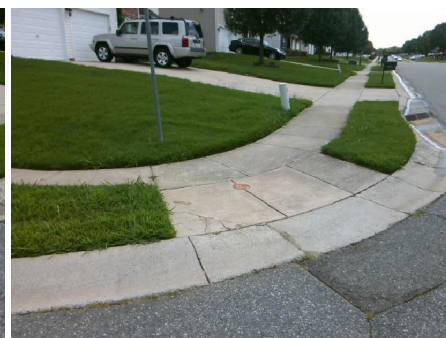
| ADA ID: 54FC9CDBC1DB | Ramp Type: PerpDiag | Initial Pass/Fail: Fail | Overall Compliance: No |
| Severity Score: 33.75 | | | |

Not Found, R304.5.1, R304.5.3

| Compliance | Description | Data | Compliance | Description | Data |
|---|---|---|---|---|---|
| No | Ramp Width (in) | 36.0 | No | Ramp XSlope (%) | 8.1 |

Remove & Replace Curb Ramp With Two New Directional Ramps or Equivalent.
