# Access Compliance Report

## Public Rights-of-Way

### (Curb Ramps)

Intersection ID: 52172	Main Street: BEARLING_WY	Cross Street: AVERY_MEADOWS_DR	Location: SE
ADA ID: 54FF5F354D12	Ramp Type: Perp	Initial Pass/Fail: Fail	Overall Compliance: No
Severity Score: 33.75			
Codes/Mitigation Info/Possible Solution		Field Measurements/Component Compliance

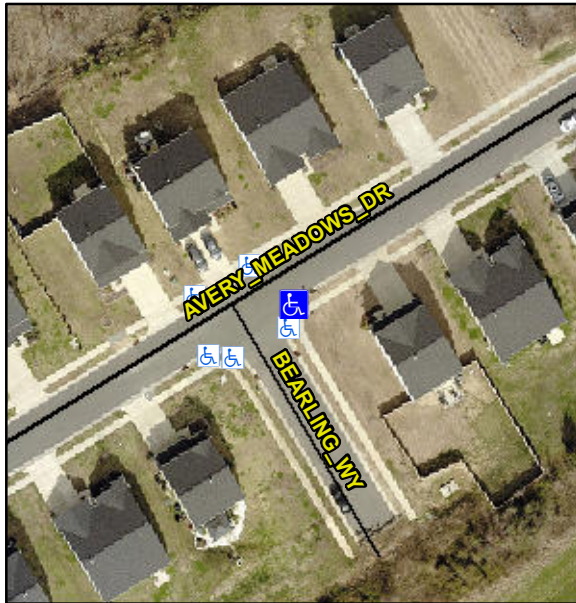
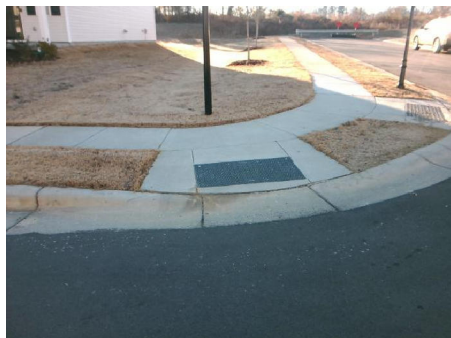
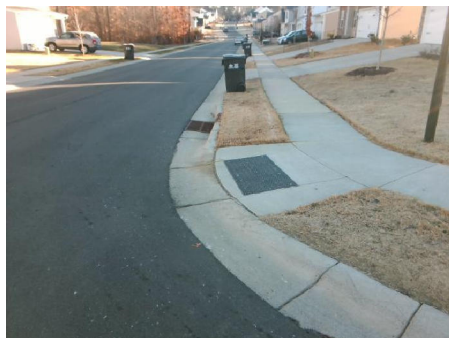
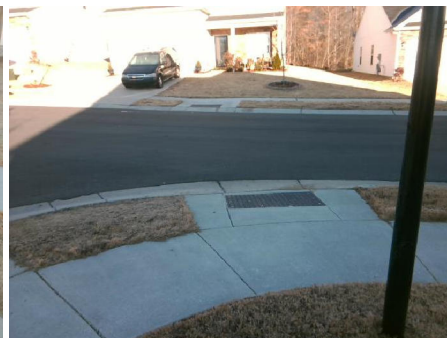
**Not Found, R304.5.1, R304.2.2, R304.5.3**

Compliance	Description	Data	Compliance	Description	Data
N/A	Ramp Length (in)	50.0	No	Ramp Slope (%)	8.9
No	Ramp Width (in)	46.0	No	Ramp XSlope (%)	5.8
N/A	Flare Type LT	N/A	N/A	Flare Type RT	N/A
N/A	Flare Slope LT (%)	N/A	N/A	Flare Slope RT (%)	N/A
N/A	Flare Traversable LT?	N/A	N/A	Flare Traversable RT?	N/A
N/A	Landing Length (in)	N/A	N/A	DWS Provided?	N/A
N/A	Landing Width (in)	N/A	N/A	DWS Contrast?	N/A
N/A	Landing Slope (%)	N/A	N/A	DWS Length (in)	N/A
N/A	Landing X Slope (%)	N/A	N/A	DWS Full Width?	N/A
N/A	Landing Curb? (Y/N)	N/A	N/A	DWS Offset (in)	N/A
N/A	Shared Landing?	N/A			
N/A	Gutter Ponding?	N/A	N/A	Gutter Slope (%)	N/A
N/A	Gutter Lip Ht (in)	N/A	N/A	Gutter X Slope (%)	N/A
N/A	Painted X Walk1?	No	N/A	Painted X Walk2?	N/A
	X Walk 1 Direction	To N		X Walk 2 Direction	N/A
N/A	X Walk 1 Width (in)	N/A	N/A	X Walk 2 Width (in)	N/A
	X Walk 1 Slope (%)	3.2		X Walk 2 Slope (%)	N/A
	X Walk 1 X Slope (%)	6.2		X Walk 2 X Slope (%)	N/A

N/A	Ramp inside XWalk1?	N/A	N/A	Ramp inside XWalk2?	N/A
	Road Slope (%)	N/A	N/A	Clear Space?	N/A
	Road X Slope (%)	N/A	N/A	Clear Space to XWalk (in)	N/A
N/A	Any Obstructions?	N/A	N/A	Storm Grate/Utility Hazard?	N/A
	Obstruction Type			Storm Grate/Utility Type	
		N/A			N/A
			Yes	Surface Condition? (G/P)	Good

**Remove & Replace Entire Ramp.**

Total Cost: \$ 1850.00
