Intersection ID: 15160	Main Street: GRIFFITH_ST	Cross Street: S_TRYON_ST	Location:	NW
ADA ID: 55055806D6C6	Ramp Type: Perp	Initial Pass/Fail: Fail	Overall Compliance: No	Severity Score: 13.75

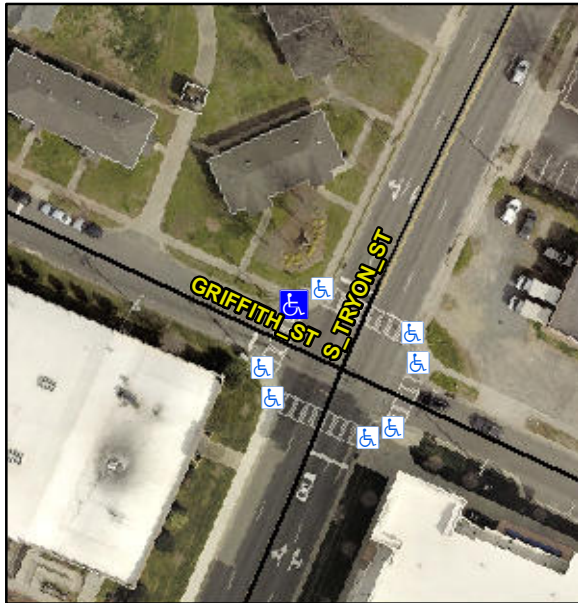
**Not Found, R304.2.2, R304.5.3**

Compliance	Description	Data	Compliance	Description	Data
N/A	Ramp Length (in)	52.0	No	Ramp Slope (%)	11.3
Yes	Ramp Width (in)	48.0	No	Ramp XSlope (%)	2.1
N/A	Flare Type LT	N/A	N/A	Flare Type RT	N/A
N/A	Flare Slope LT (%)	N/A	N/A	Flare Slope RT (%)	N/A
N/A	Flare Traversable LT?	N/A	N/A	Flare Traversable RT?	N/A
N/A	Landing Length (in)	N/A	N/A	DWS Provided?	N/A
N/A	Landing Width (in)	N/A	N/A	DWS Contrast?	N/A
N/A	Landing Slope (%)	N/A	N/A	DWS Length (in)	N/A
N/A	Landing X Slope (%)	N/A	N/A	DWS Full Width?	N/A
N/A	Landing Curb? (Y/N)	N/A	N/A	DWS Offset (in)	N/A
N/A	Shared Landing?	N/A			
N/A	Gutter Ponding?	N/A	N/A	Gutter Slope (%)	N/A
N/A	Gutter Lip Ht (in)	N/A	N/A	Gutter X Slope (%)	N/A
N/A	Painted X Walk1?	Yes	N/A	Painted X Walk2?	N/A
	X Walk 1 Direction	To SW		X Walk 2 Direction	N/A
N/A	X Walk 1 Width (in)	106.0	N/A	X Walk 2 Width (in)	N/A
	X Walk 1 Slope (%)	1.0		X Walk 2 Slope (%)	N/A
	X Walk 1 X Slope (%)	1.0		X Walk 2 X Slope (%)	N/A

N/A	Ramp inside XWalk1?	Yes	N/A	Ramp inside XWalk2?	N/A
	Road Slope (%)	N/A	N/A	Clear Space?	N/A
	Road X Slope (%)	N/A	N/A	Clear Space to XWalk (in)	N/A
N/A	Any Obstructions?	N/A	N/A	Storm Grate/Utility Hazard?	N/A
	Obstruction Type			Storm Grate/Utility Type	
		N/A			N/A
			Yes	Surface Condition? (G/P)	Good

### Remove & Replace Entire Ramp.
