Access Compliance Report Public Rights-of-Way (Curb Ramps)

Main Street: N WENDOVER RD Intersection ID: 15397 Cross Street: N WENDOVER RD RA Location: W **Overall Compliance: No Severity Score:** 22.5 **ADA ID: 5507B9BBA7E9** Ramp Type: Perp Initial Pass/Fail: Fail

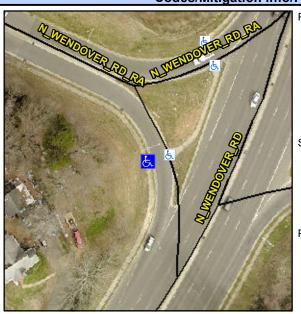
Compliance Description Possible Solutions: N/A Remove & Replace Entire Ramp. No N/A Surveyor Notes: N/A PROW/ADA: R304.5.1, R304.2.2
