Access Compliance Report

Public Rights-of-Way

(Curb Ramps)

Intersection ID: 16513	Main Street: BILTMORE_DR	Cross Street: COLVILLE_RD	Location: NW
ADA ID: 5515212646CA	Ramp Type: Perp	Initial Pass/Fail: Fail	Overall Compliance: No
		Severity Score: 22.5

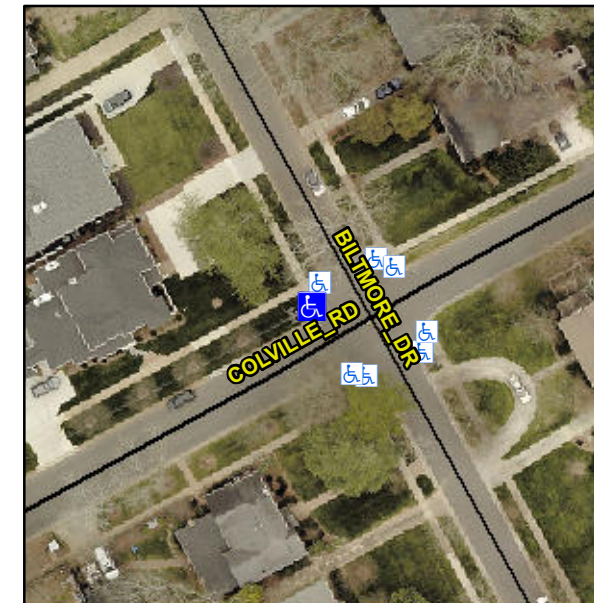
Not Found, R304.5.1, R304.2.2, R304.5.3

Compliance	Description	Data	Compliance	Description	Data
N/A	Ramp Length (in)	58.0	No	Ramp Slope (%)	10.0
No	Ramp Width (in)	36.0	No	Ramp XSlope (%)	3.6
N/A	Flare Type LT	N/A	N/A	Flare Type RT	N/A
N/A	Flare Slope LT (%)	N/A	N/A	Flare Slope RT (%)	N/A
N/A	Flare Traversable LT?	N/A	N/A	Flare Traversable RT?	N/A
N/A	Landing Length (in)	N/A	N/A	DWS Provided?	N/A
N/A	Landing Width (in)	N/A	N/A	DWS Contrast?	N/A
N/A	Landing Slope (%)	N/A	N/A	DWS Length (in)	N/A
N/A	Landing X Slope (%)	N/A	N/A	DWS Full Width?	N/A
N/A	Landing Curb? (Y/N)	N/A	N/A	DWS Offset (in)	N/A
N/A	Shared Landing?	N/A			
N/A	Gutter Ponding?	N/A	N/A	Gutter Slope (%)	N/A
N/A	Gutter Lip Ht (in)	N/A	N/A	Gutter X Slope (%)	N/A
N/A	Painted X Walk1?	No	N/A	Painted X Walk2?	N/A
	X Walk 1 Direction	To S		X Walk 2 Direction	N/A
N/A	X Walk 1 Width (in)	N/A	N/A	X Walk 2 Width (in)	N/A
	X Walk 1 Slope (%)	3.5		X Walk 2 Slope (%)	N/A
	X Walk 1 X Slope (%)	2.3		X Walk 2 X Slope (%)	N/A

N/A	Ramp inside XWalk1?	N/A	N/A	Ramp inside XWalk2?	N/A
	Road Slope (%)	N/A	N/A	Clear Space?	N/A
	Road X Slope (%)	N/A	N/A	Clear Space to XWalk (in)	N/A
N/A	Any Obstructions?	N/A	N/A	Storm Grate/Utility Hazard?	N/A
	Obstruction Type			Storm Grate/Utility Type	
		N/A			N/A
			Yes	Surface Condition? (G/P)	Good

Remove & Replace Entire Ramp.
